MSW PA\_1505A\_CO\_20160406\_Investigation Report  
Texas Commission on Environmental Quality  
Investigation Report

**Regulated Entity Name: BLUE RIDGE LANDFILL**

**Investigation # 1323599**

**Activity Type(s):** MSWC MPL - Investigation of MSW  
complaint

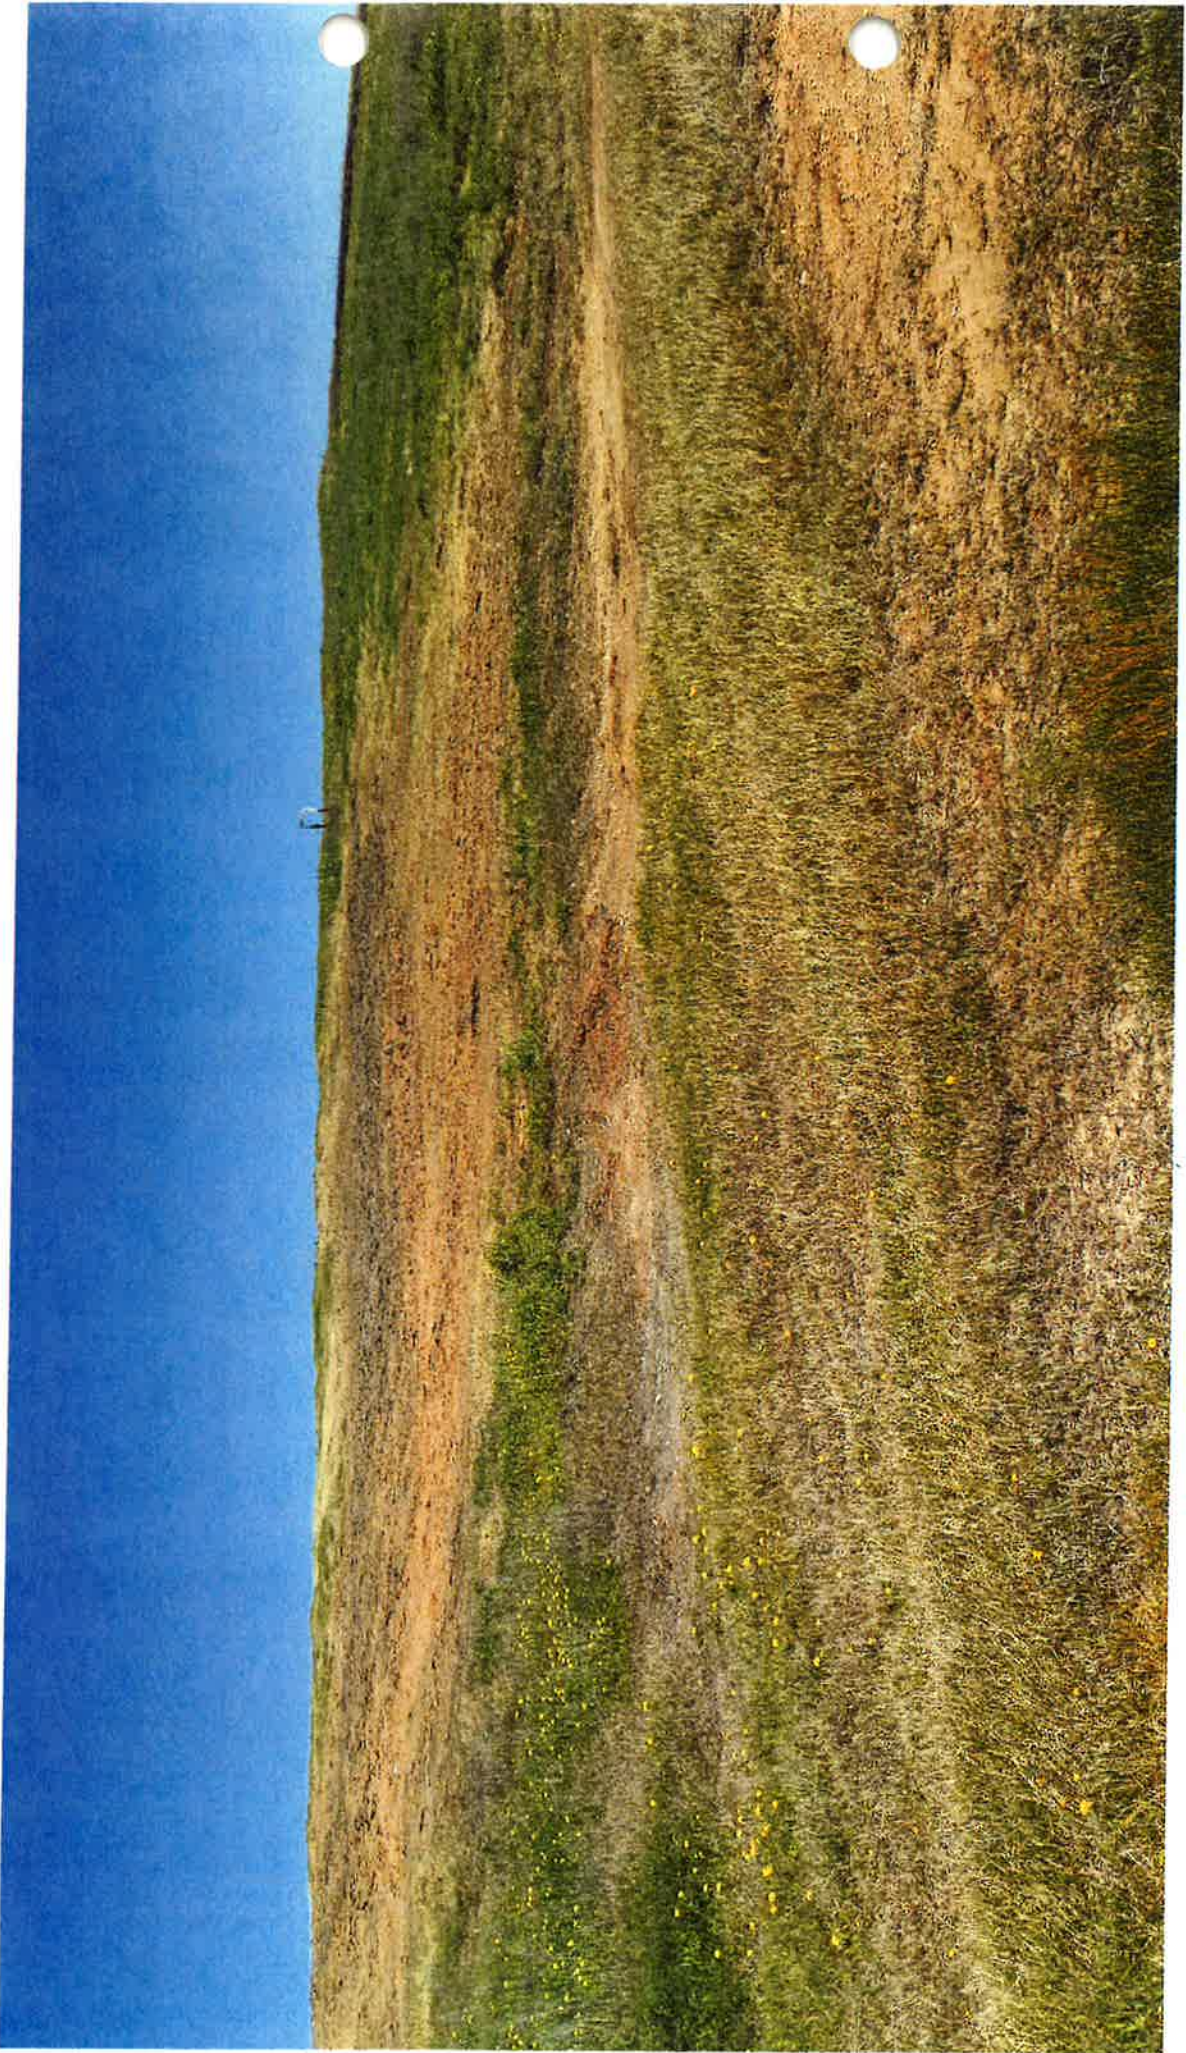
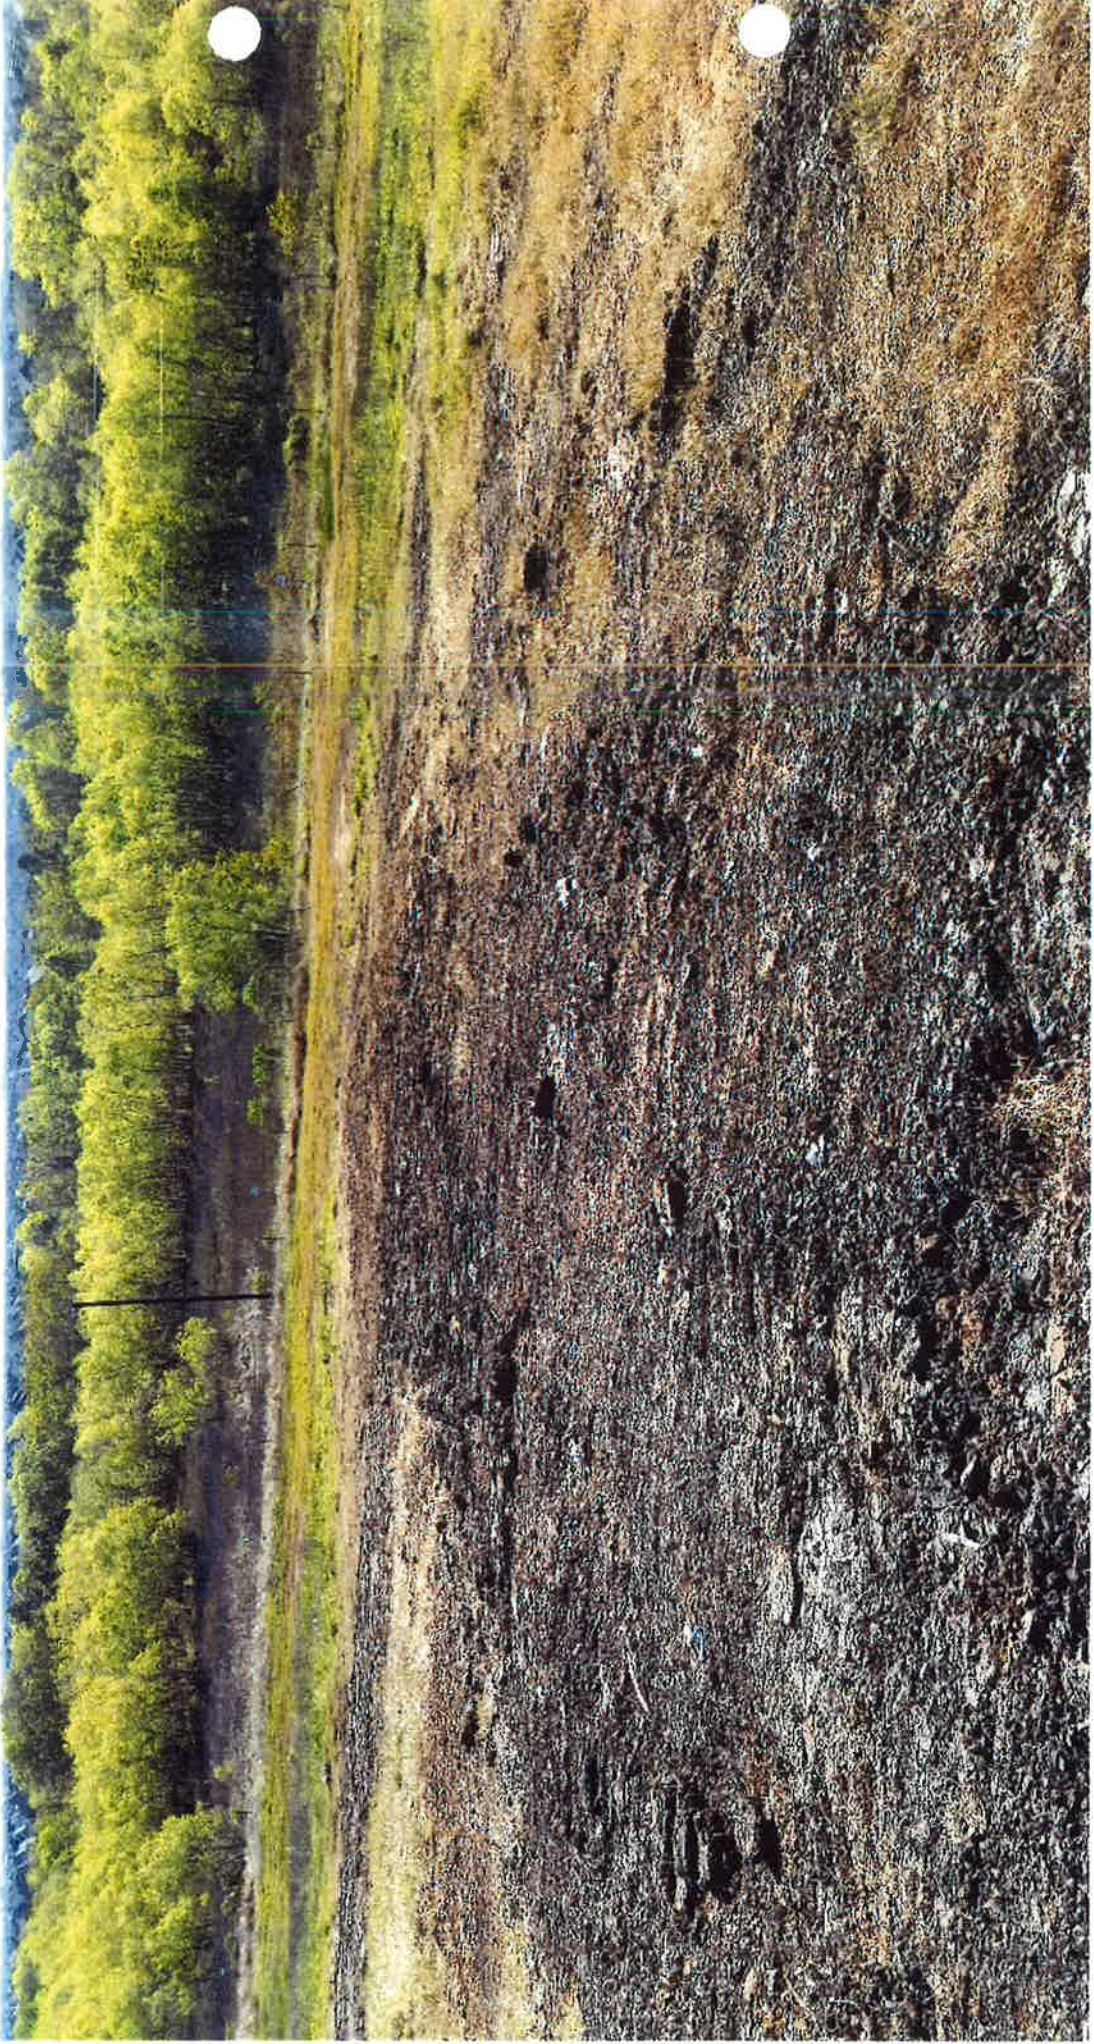
On March 29, 2016, Mr. Burgess Stengl, Environmental Manager for Republic Services, sent the investigator photographs (Attachment 1) showing repairs made to a portion of the eastern slope of the landfill.

Richard, per our discussion, attached are the pictures showing the repairs made on the east slope of Phase 3 of the Blue Ridge Landfill (MSW 1505A).

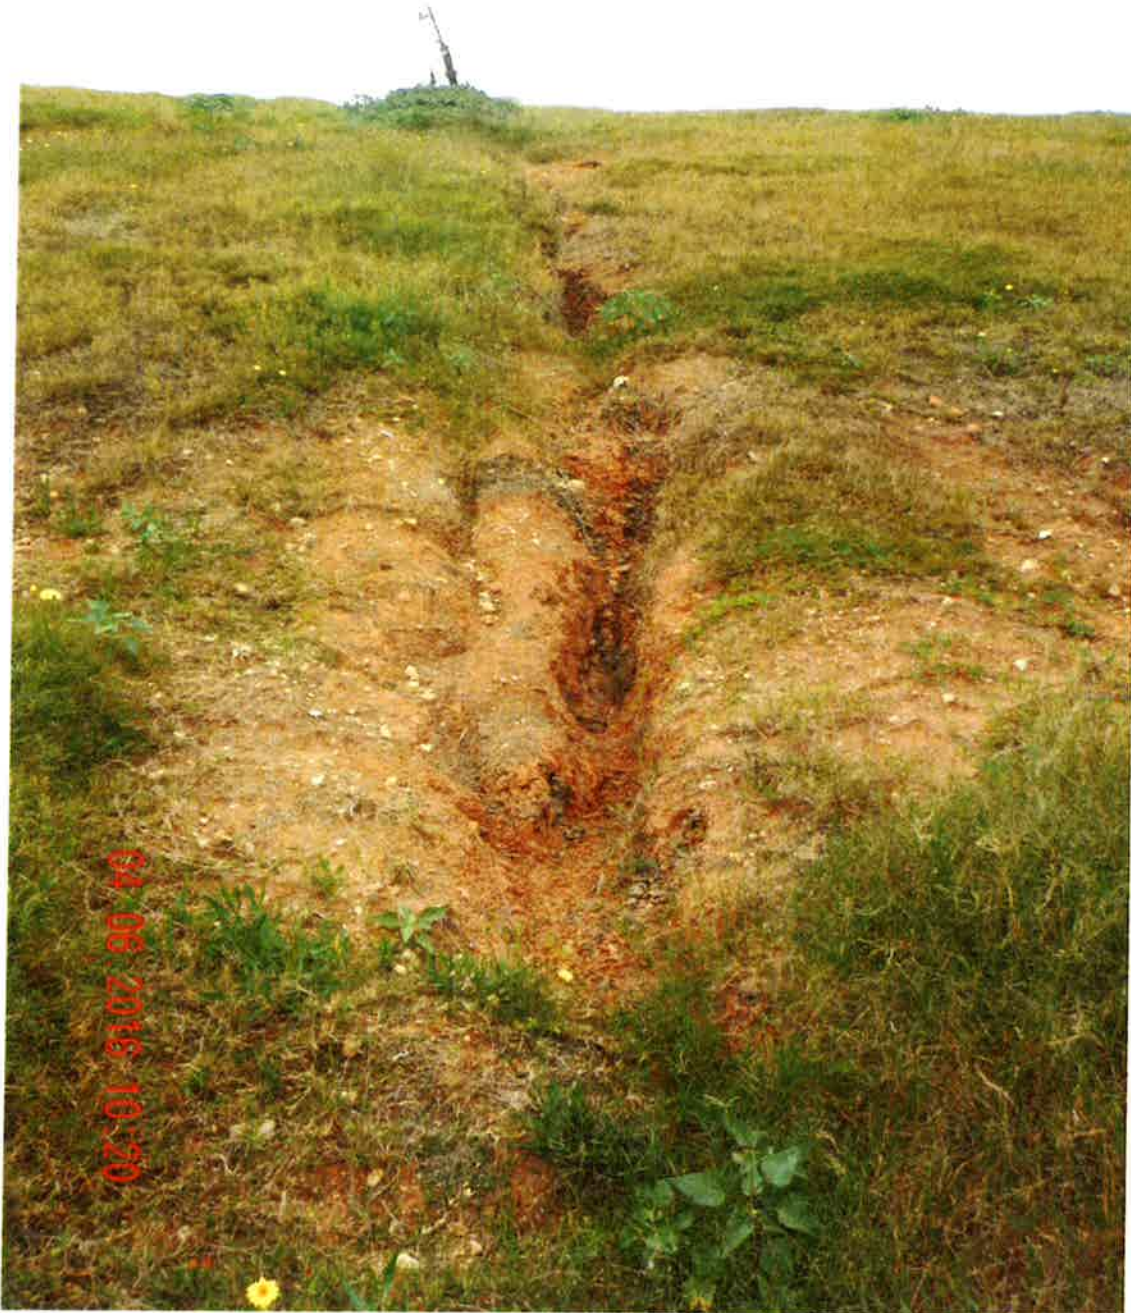
On the eastern slope of the landfill, the investigator viewed an area where erosion had previously been observed. That erosion gully had been repaired, but another erosion gully was noted. A photograph, taken by the investigator, is included in Attachment 5. On the western side of the landfill, the investigator observed that soil had been laid as part of BRL's effort to address all areas of erosion.

Erosion of cover was observed at Blue Ridge Landfill on December 18, 2015, and the date of detection was not in the cover log, nor a reason for delay of repair of cover. On January 5, 2016, the facility representative sent photographs to the TCEQ showing repair of cover at the northern slope. On March 2, 2016, that area was observed in person to have been fully repaired. However, another area of erosion of cover was observed on the eastern slope. On March 29, 2016, the facility representative sent the investigator photographs showing repairs made to that portion of the eastern slope. The repair was observed in person on April 6, 2016, but another area of erosion was also observed.

Photograph 1 of 1: An erosion gully

Blue Ridge Landfill is requested to restore the cover material and include the date of completion of repairs in the cover log. The facility is requested to submit documentation to the TCEQ Houston Region Office to verify compliance.
