MSW PA_1505A_CO_20160805_Investigation Report
Texas Commission on Environmental Quality
Investigation Report

Regulated Entity Name: BLUE RIDGE LANDFILL

Conducted: 08/05/2016 -- 10/18/2016

Investigation Type: Compliance Investigation

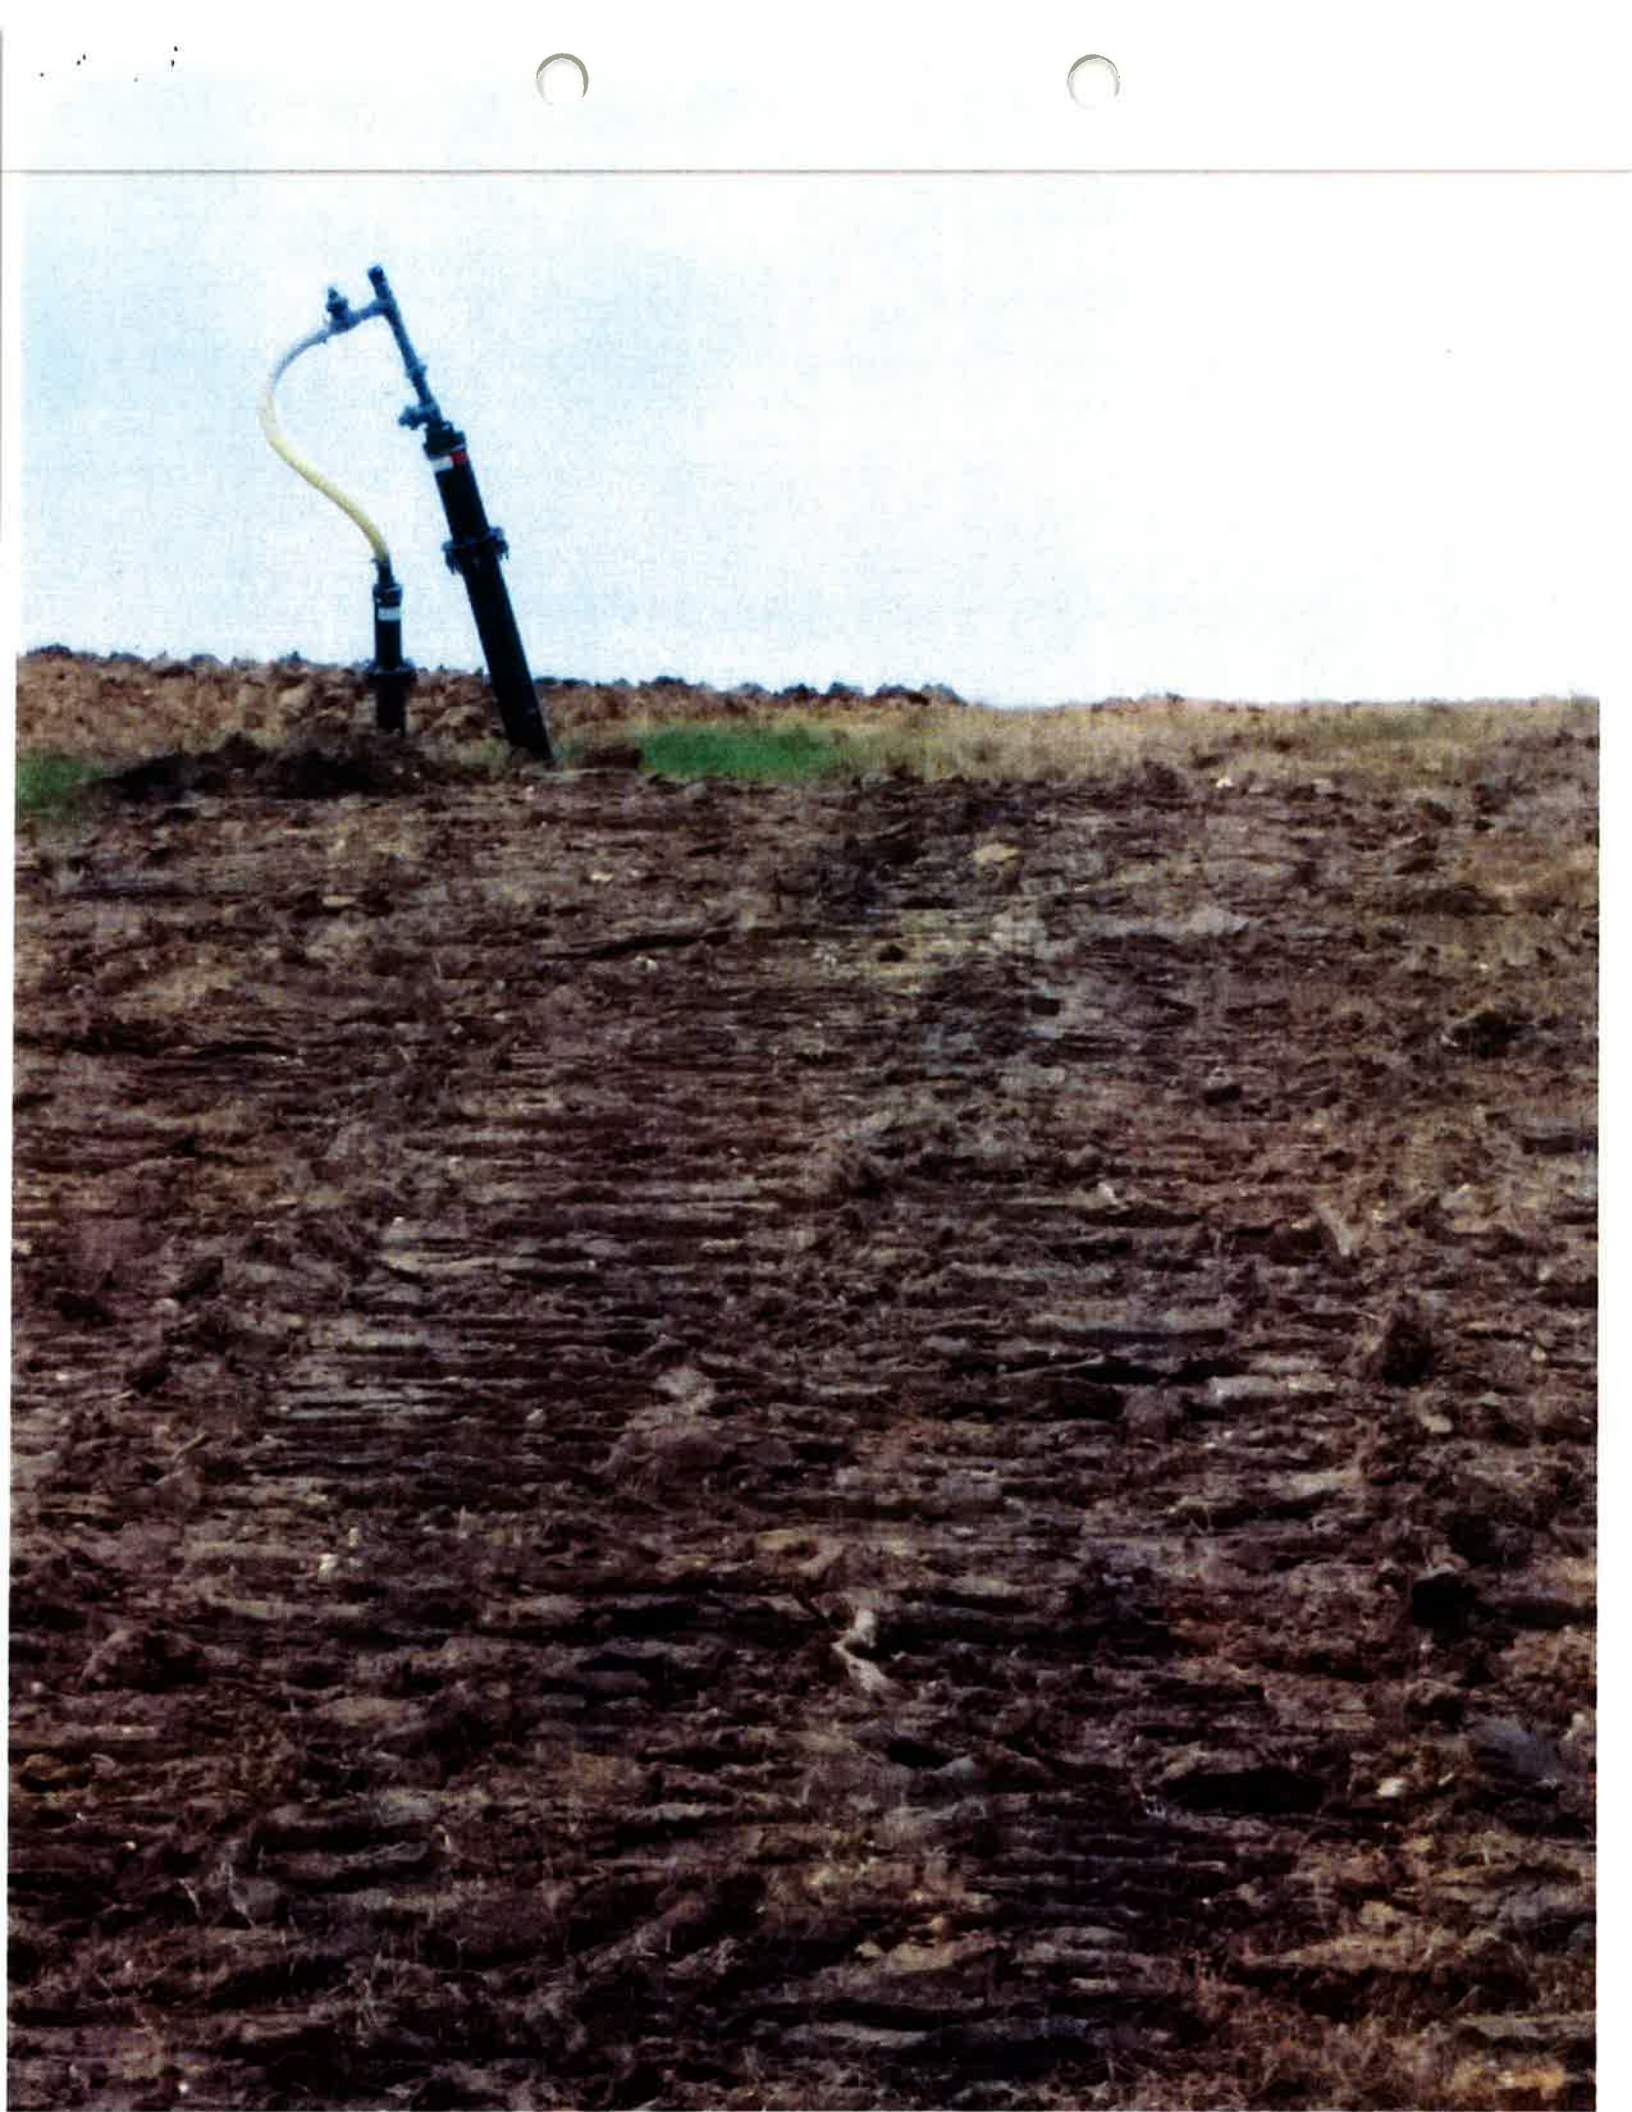
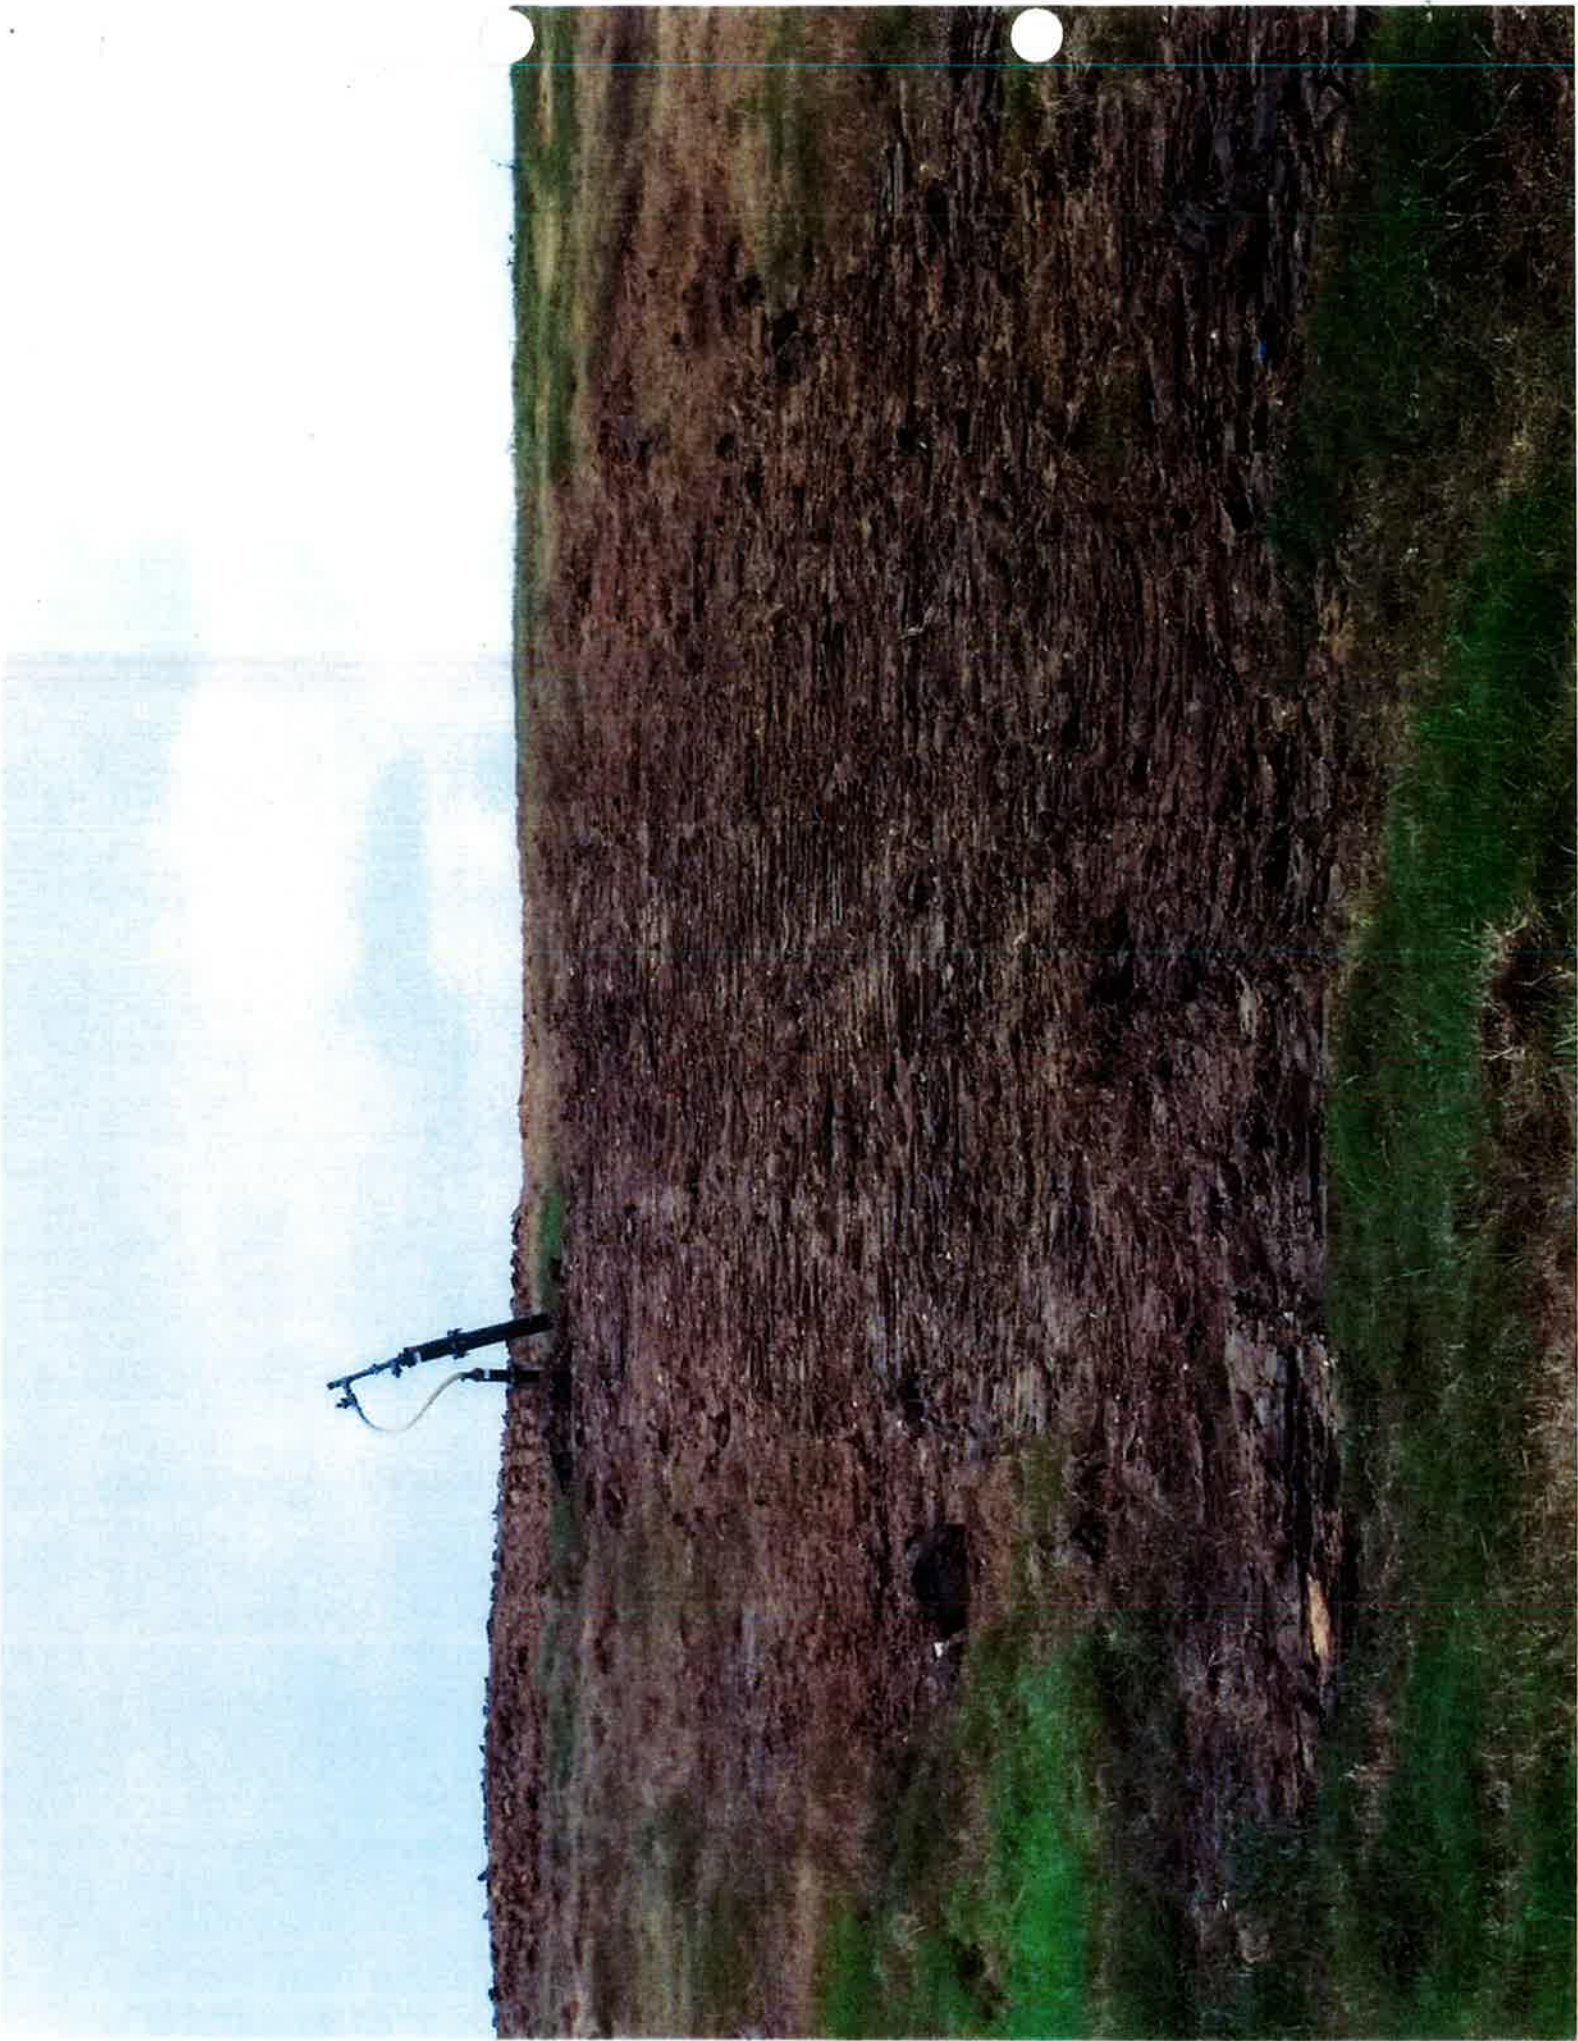
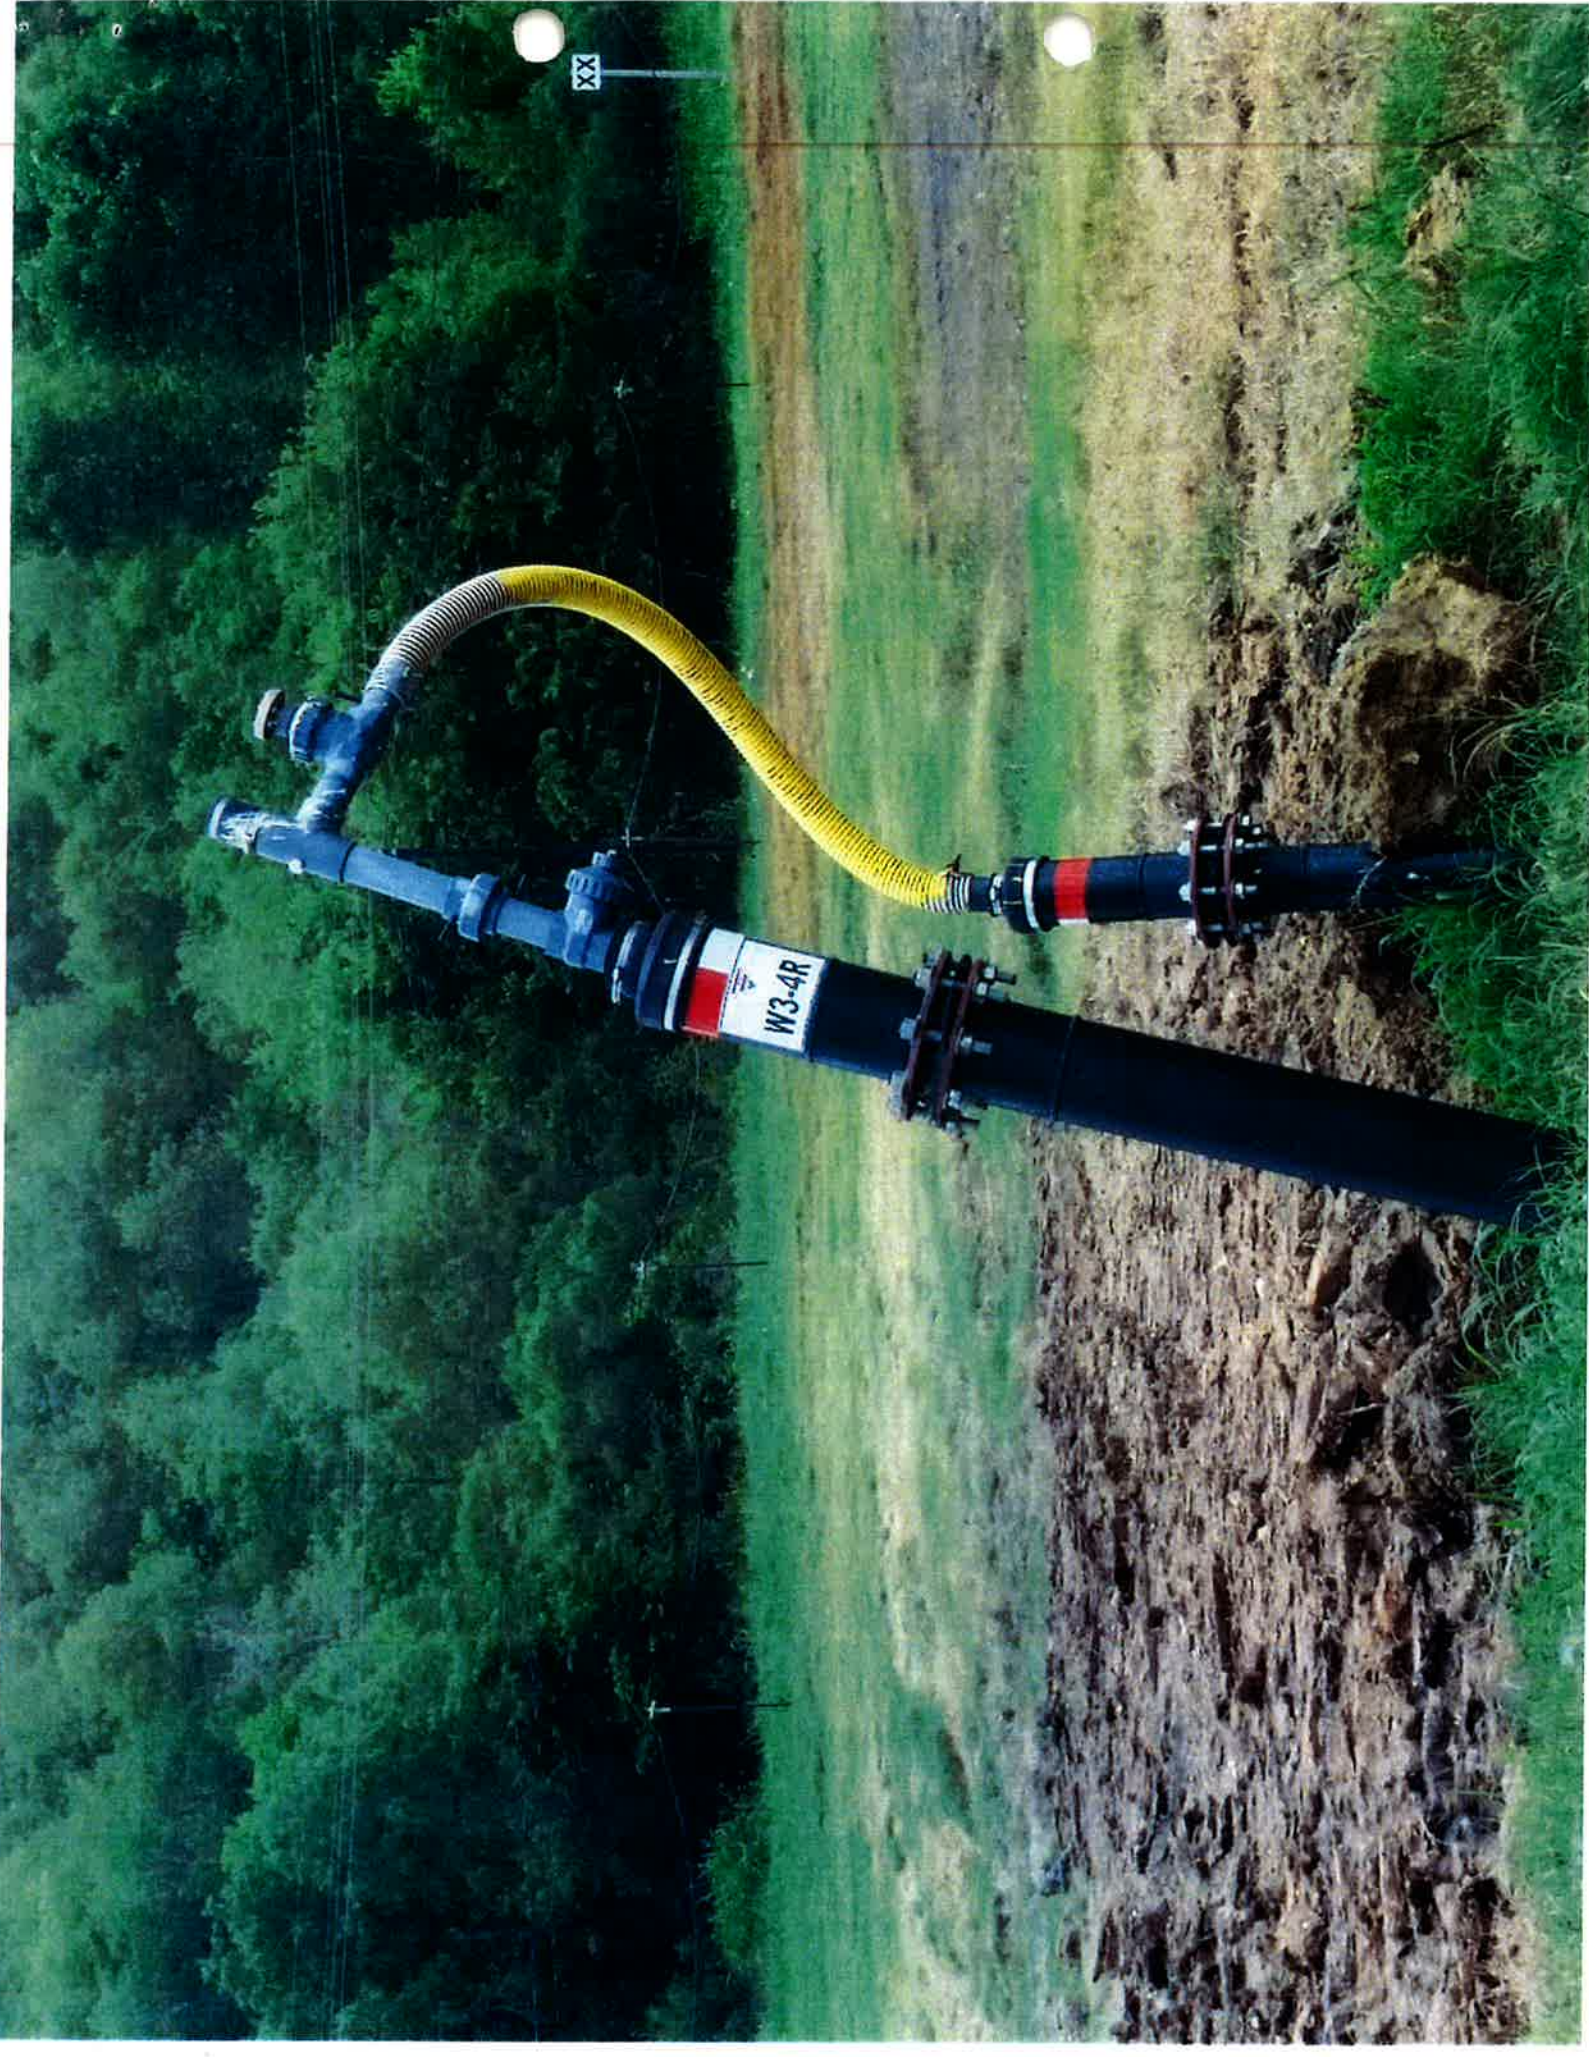
This letter is submitted on behalf of the Blue Ridge Landfill TX, LP (Landfill) to respond to your July 1, 2016 request for additional compliance documentation for an outstanding alleged violation. The outstanding alleged violation involves erosion of cover that was observed at the Landfill by Mr. Richard Blackney on April 6, 2016. I have attached three photos of the areas that Mr. Blackney observed having erosion of more than four inches in depth (Attachments).

This letter, along with the three photographs, should be adequate documentation that the Blue Ridge Landfill continues to strive for compliance with the TCEQ regulations regardless of weather-related issues.
