MSW PA_1505A_CO_20160411_Investigation Report
Texas Commission on Environmental Quality
Investigation Report

Regulated Entity Name: BLUE RIDGE LANDFILL

Re: Additional Compliance Documentation Needed for:
Blue Ridge Landfill, 2200 FM 521 Rd., Fresno (Fort Bend County), Texas 77545
TCEQ Municipal Solid Waste Permit No.: 1505A

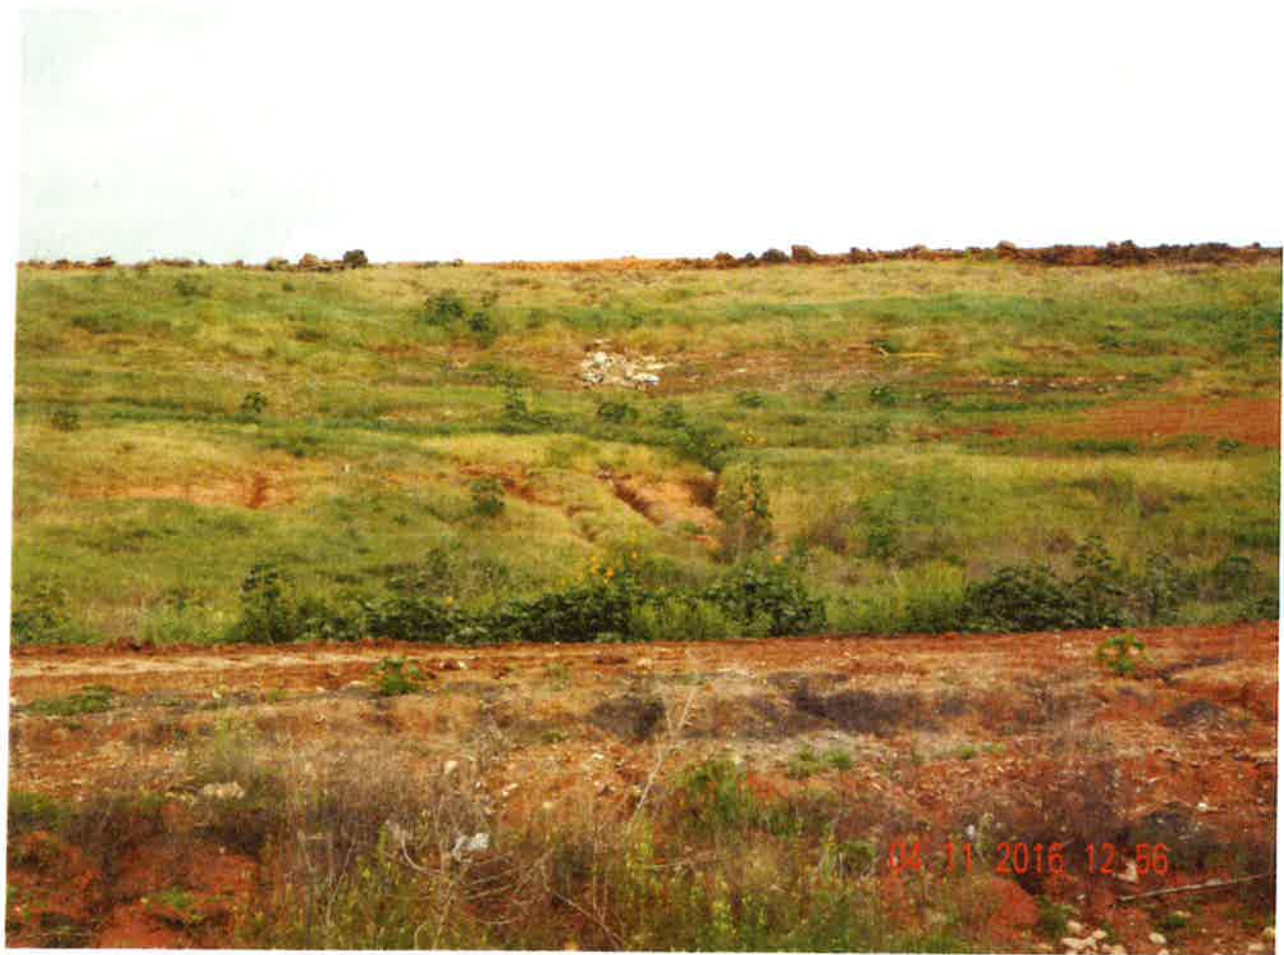
Photograph 1 of 1: Erosion gullies

The investigator viewed the northern slope of the landfill, where erosion had been observed on December 18, 2015. The erosion appeared to have been repaired. On the western side of the landfill, the investigator observed that soil had been laid as part of BRL's effort to address all areas of erosion. However, at least one erosion gully greater than four inches deep was observed to be in need of repair at the time of the investigation. A photograph taken by the investigator is included in Attachment 4.

On January 5, 2016, and March 29, 2016, the facility representative sent photographs to the TCEQ showing repair of cover. On April 11, 2016, repair of many of the areas of erosion were observed, but some erosion gullies greater than four inches deep were still observed.

Blue Ridge Landfill is requested to restore the cover material and include the date of completion of repairs in the cover log. The facility is requested to submit documentation to the TCEQ Houston Region Office to verify compliance.
