MSW PA_1505A_CO_20160425_Investigation Report
Texas Commission on Environmental Quality
Investigation Report

Regulated Entity Name: BLUE RIDGE LANDFILL

Activity Type(s): MSWC MPL - Investigation of MSW
complaint

SUMMARY OF INVESTIGATION FINDINGS
Blue Ridge Landfill
2200 F.M. 521, Fresno (Fort Bend County), TX 77545
Municipal Solid Waste Permit No. 1505A
MSW Complaint Investigation
Conducted on April 25, 2016

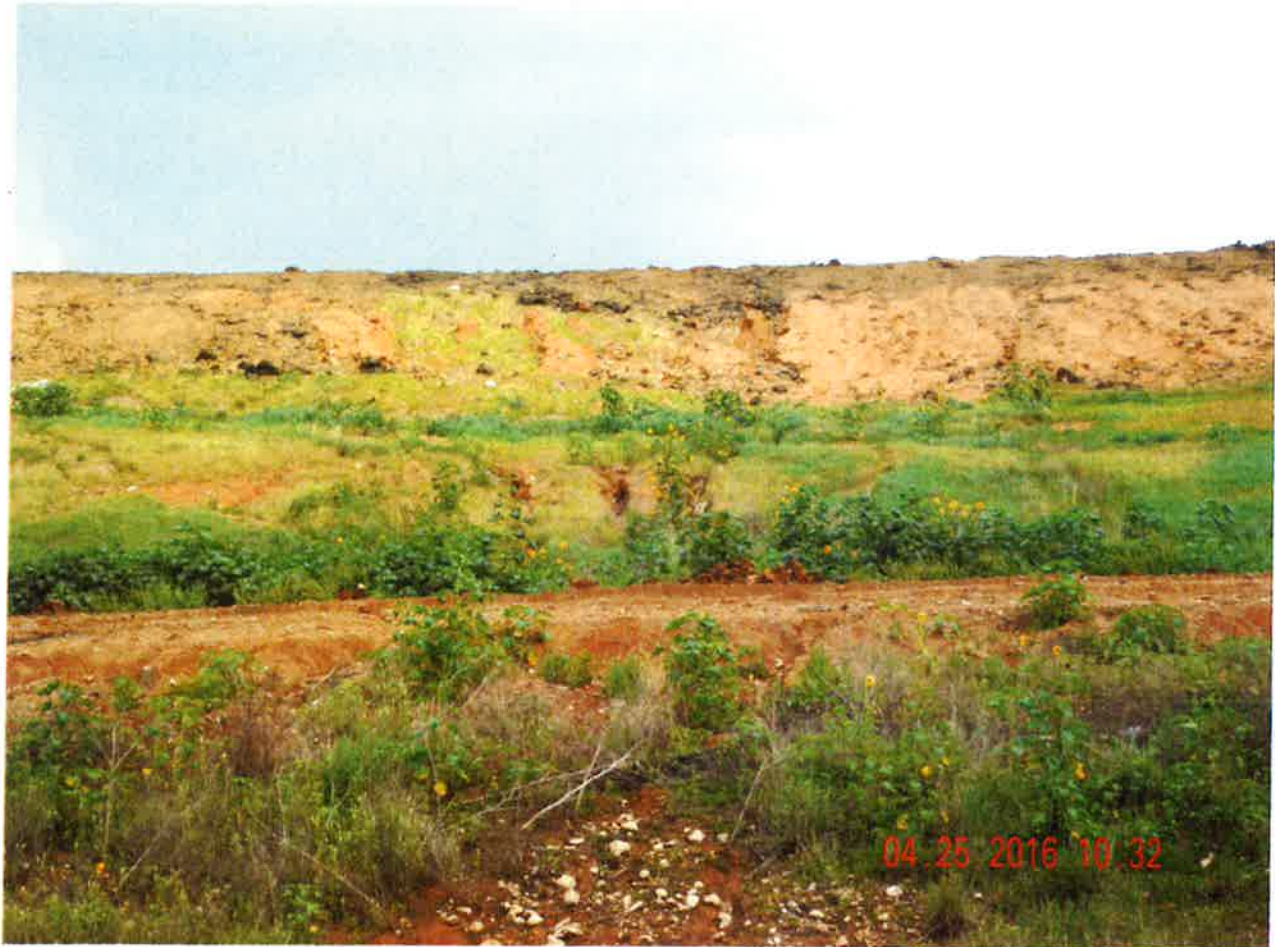
On the western side of the landfill, the investigator observed that soil had been laid and compacted as part of BRL's effort to address all areas of erosion. However, at least one erosion gully greater than four inches deep was observed to be in need of repair at the time of the investigation. A photograph taken by the investigator is included in Attachment 4.

Erosion of cover was observed at Blue Ridge Landfill on December 18, 2015, and the date of detection was not in the cover log, nor a reason for delay of repair of cover.

Photograph 1 of 1: Erosion gullies that appeared to be greater than four inches deep.

Blue Ridge Landfill is requested to restore the cover material and include the date of completion of repairs in the cover log. The facility is requested to submit documentation to the TCEQ Houston Region Office to verify compliance.
