MSW PA_1505A_CO_20160517_Investigation Report
Texas Commission on Environmental Quality
Investigation Report

Regulated Entity Name: BLUE RIDGE LANDFILL

Investigation Type: Compliance Investigation

SUMMARY OF INVESTIGATION FINDINGS
Blue Ridge Landfill
2200 F.M. 521, Fresno (Fort Bend County), TX 77545
Municipal Solid Waste Permit No. 1505A
MSW Complaint Investigation
Conducted on May 17, 2016

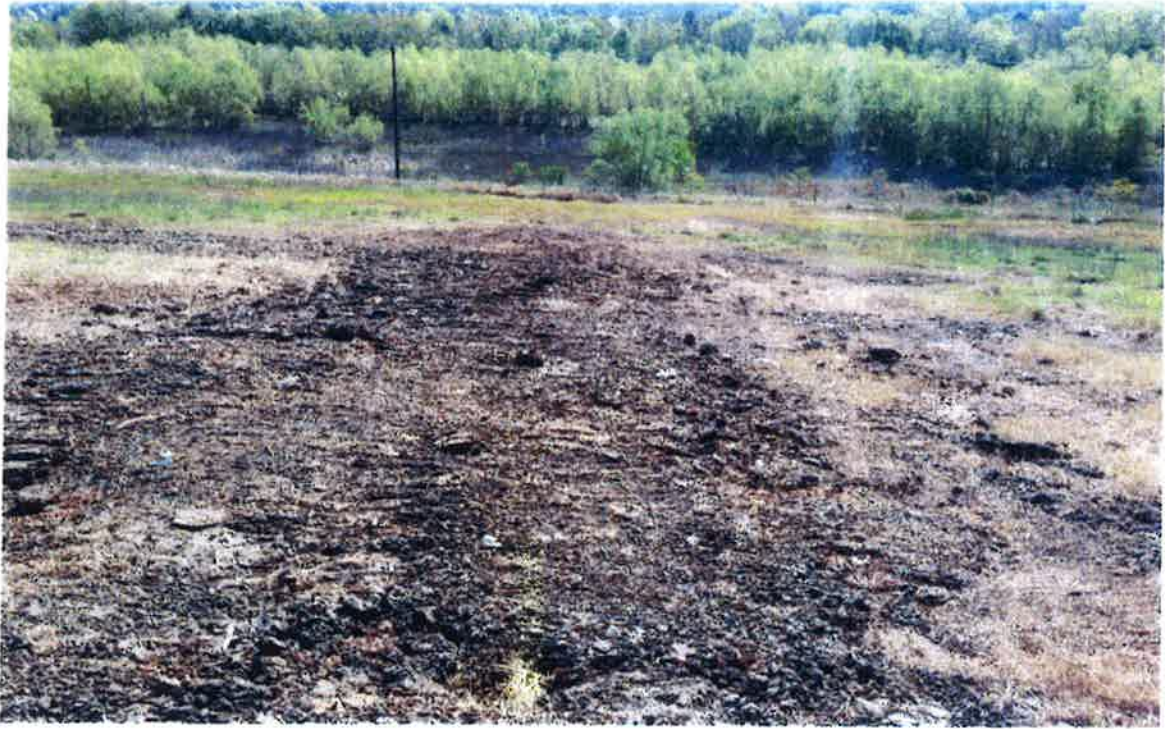
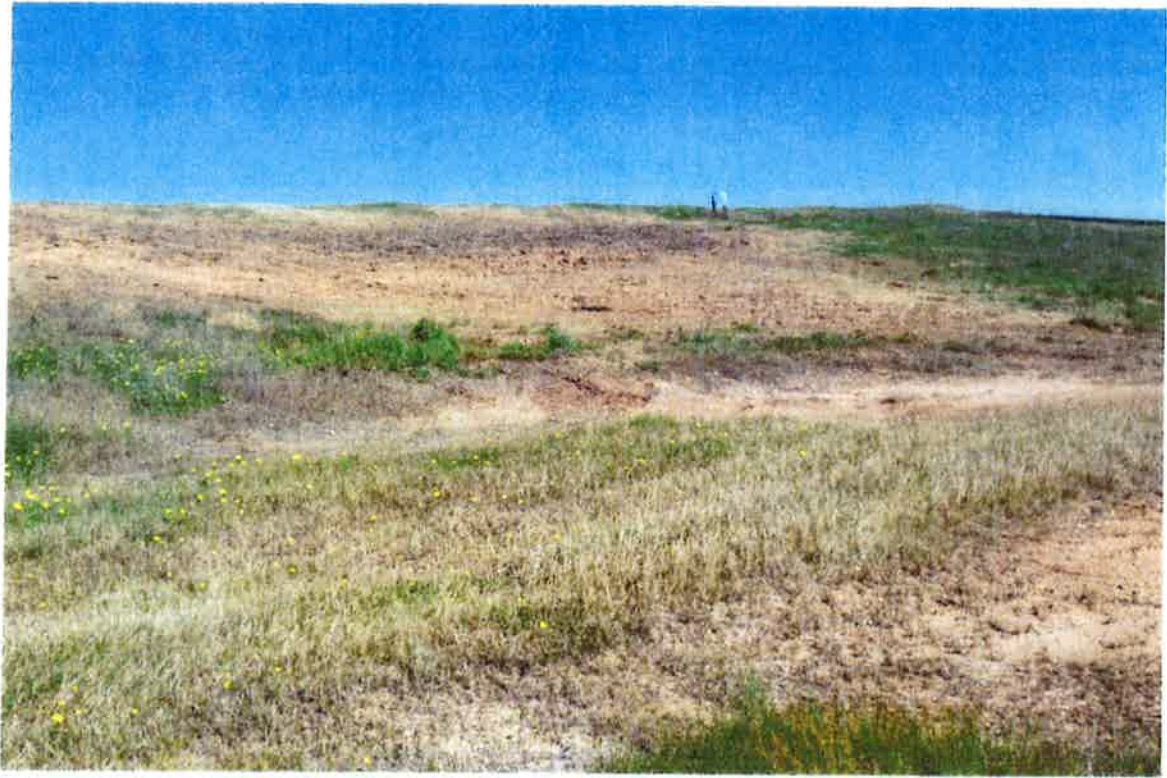
Attachment 1

This letter is submitted on behalf of the Blue Ridge Landfill TX, LP (Landfill) to respond to your April 8, 2016 request for additional compliance documentation for an outstanding alleged violation. The outstanding alleged violation involves erosion of cover that was observed at the Landfill by Mr. Richard Blackney. I have attached two photos of the area that Mr. Blackney observed having erosion of more than four inches in depth, and provided to Mr. Blackney on March 29, 2016 (Attachment 1). Since these photos were taken, additional erosion has occurred due to rain events on April 17, 18 and 24, 2016. These areas have been noted on the Site Cover Log, however, because of the continuing rain events, the newly documented erosion cannot be repaired in the required five days after detection. For this reason, an extension was requested, and was granted by Mr. Jason Ybarra of your office on April 29, 2016. I have included a copy of Mr. Ybarra's letter as Attachment 2.

The letter, along with the two photographs, should be adequate documentation that the Blue Ridge Landfill continues to strive for compliance with the TCEQ regulations regardless of weather-related issues.

On May 3 and May 17, 2016, the TCEQ Houston Region Office received letters from Blue Ridge Landfill that included photographs showing repair of erosion. However, not all of the erosion features were repaired at the time of the May 17, 2016 investigation.

Blue Ridge Landfill is requested to restore the cover material and include the date of completion of repairs in the cover log. The facility is requested to submit documentation to the TCEQ Houston Region Office to verify compliance.

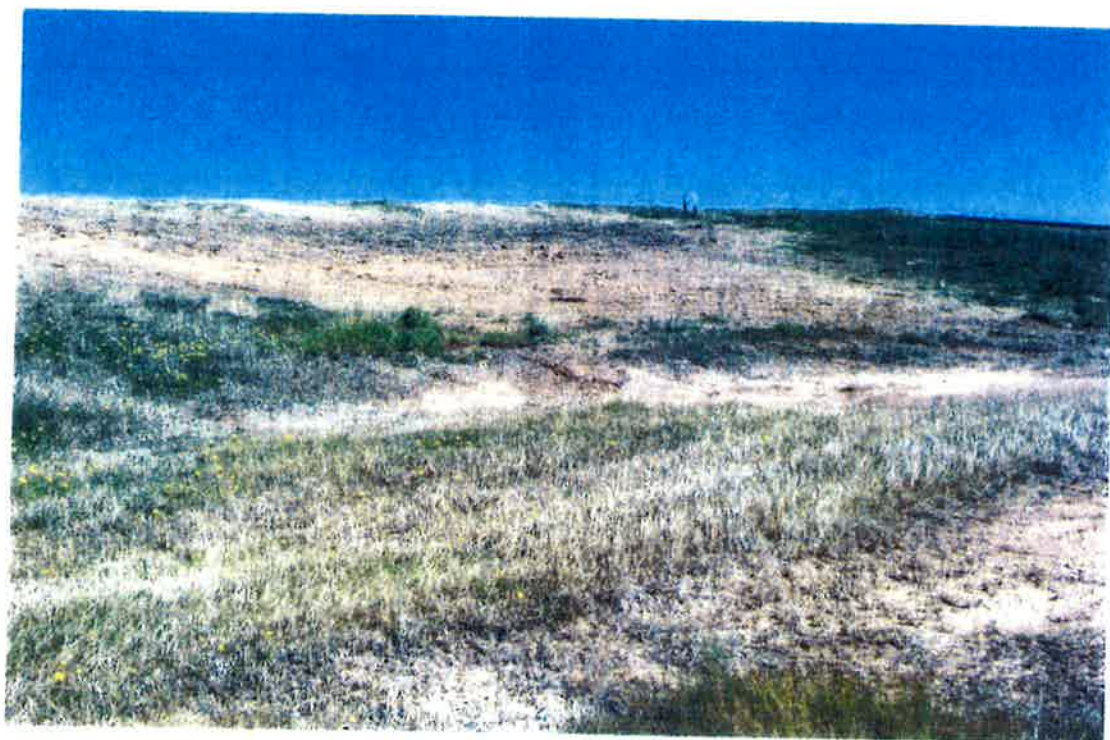
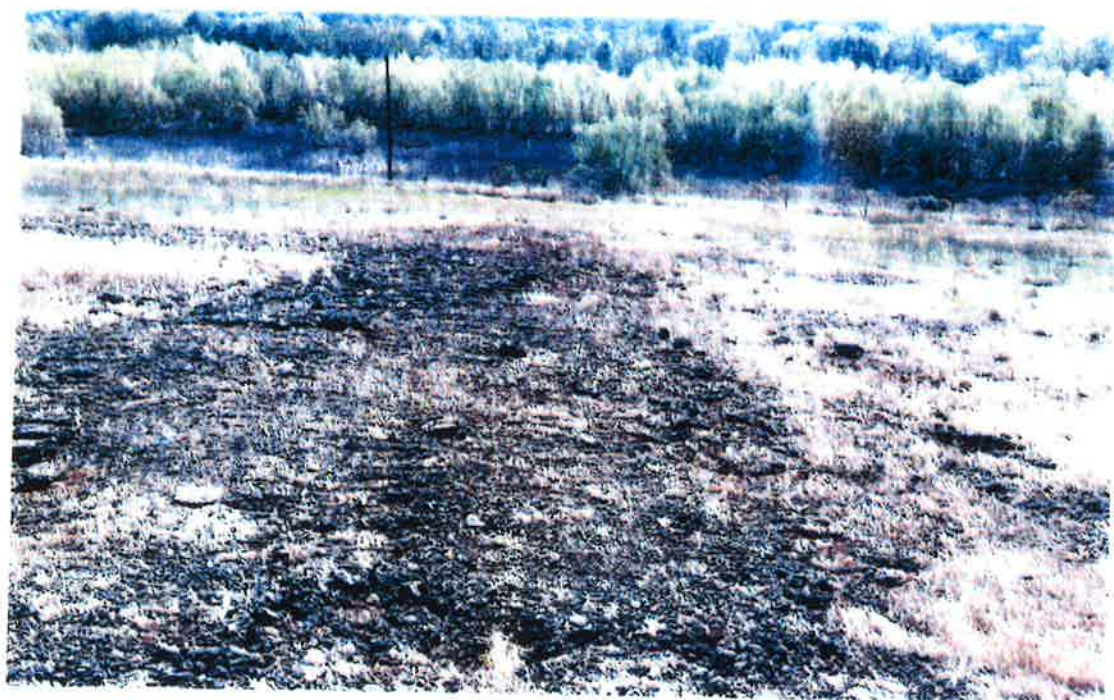
Attachment 1

This letter is submitted on behalf of the Blue Ridge Landfill TX, LP (Landfill) to respond to your April 28, 2016 request for additional compliance documentation for an outstanding alleged violation. The outstanding alleged violation involves erosion of cover that was observed at the Landfill by Mr. Richard Blackney. I have attached two photos of the area that Mr. Blackney observed having erosion of more than four inches in depth, and provided to Mr. Blackney on March 29, 2016 (Attachment 1). Since these photos were taken, additional erosion has occurred due to rain events on April 17, 18 and 24, 2016. These areas have been noted on the Site Cover Log, however, because of the continuing rain events, the newly documented erosion cannot be repaired in the required five days after detection. For this reason, an extension was requested, and was granted by Mr. Jason Ybarra of your office on April 29, 2016. I have included a copy of Mr. Ybarra's letter as Attachment 2.
