MSW PA_1505A_CO_201711_Investigation Report
Texas Commission on Environmental Quality
Investigation Report

Regulated Entity Name: BLUE RIDGE LANDFILL

Investigation Type: Compliance Investigation

Investigation Comments:**INTRODUCTION**

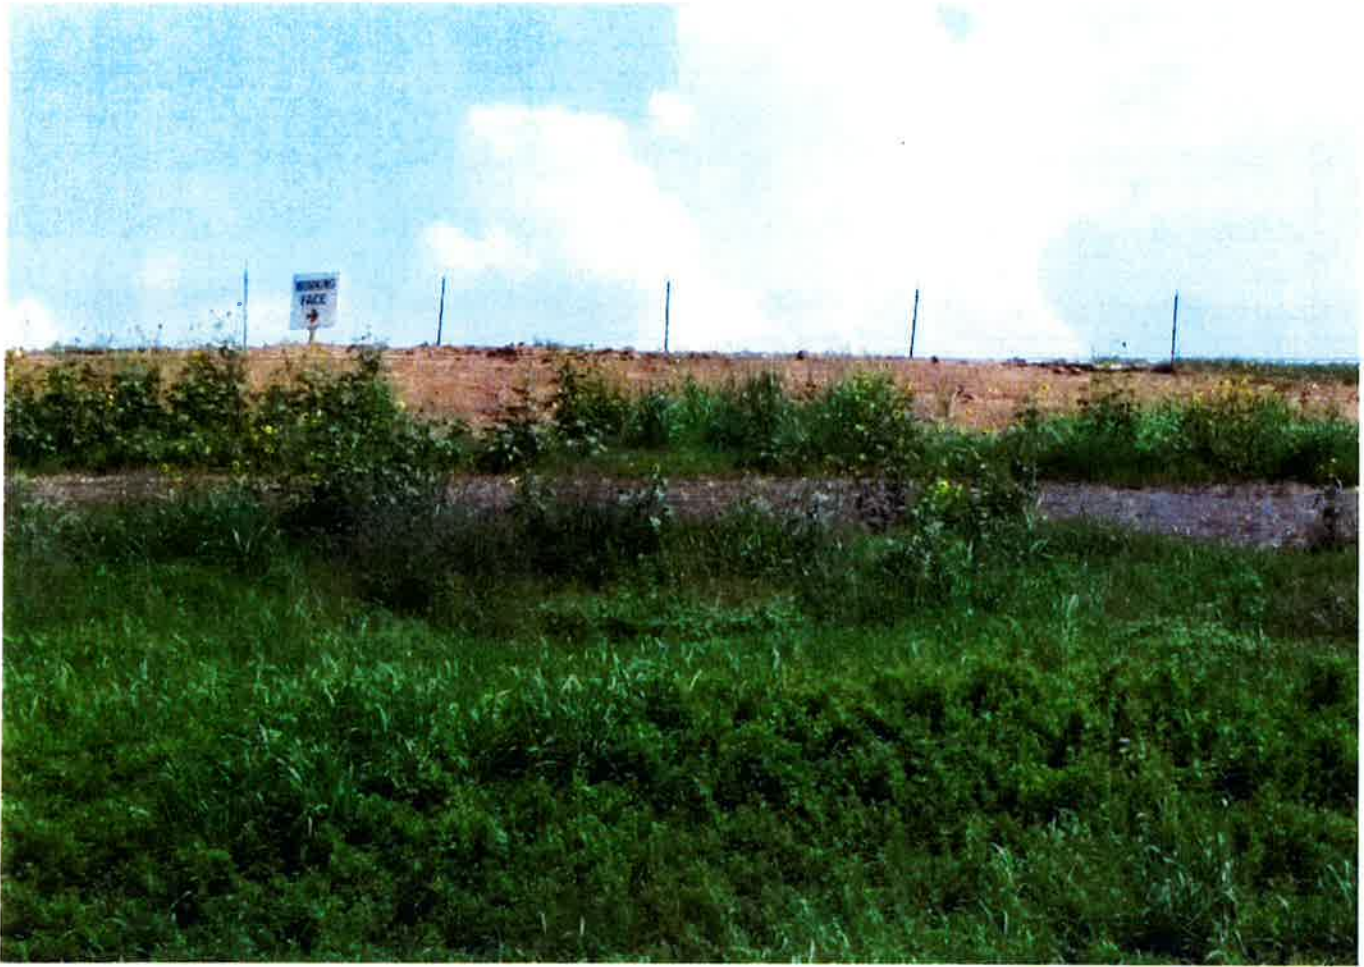
6/20/16

This letter is submitted on behalf of the Blue Ridge Landfill TX, LP (Landfill) to respond to your May 31, 2016 request for additional compliance documentation for an outstanding alleged violation. The outstanding alleged violation involves erosion of cover that was observed at the Landfill by Mr. Richard Blackney on March 14, 2016. I have attached four photos of the areas that Mr. Blackney observed having erosion of more than four inches in depth (Attachments).

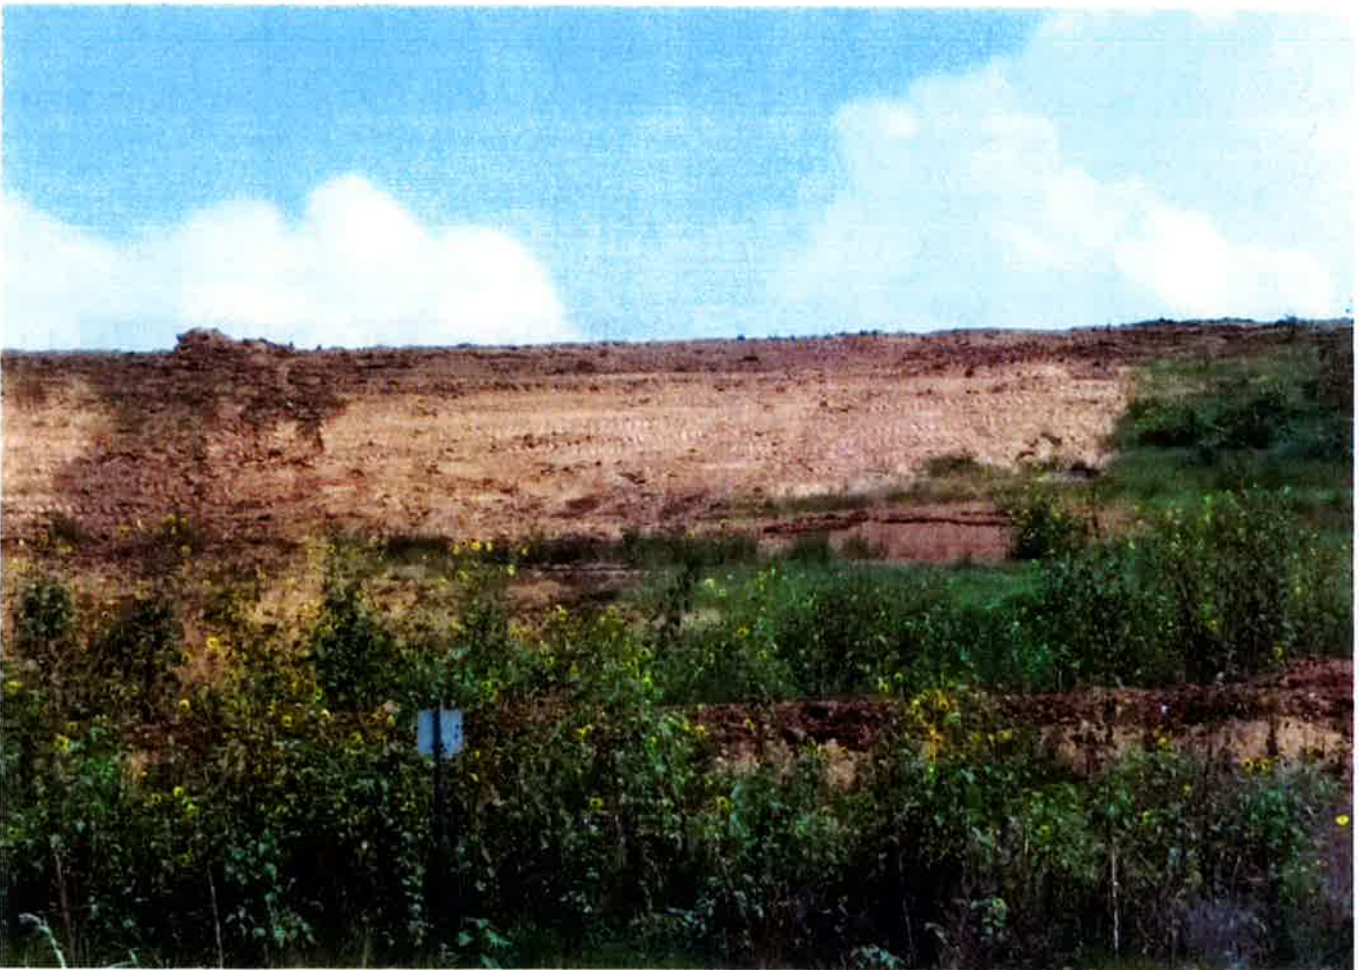
6/20/16

Richard, I will be sending a formal letter with pictures to TCEQ Region 12 after the next erosion letter arrives, but wanted to send you these pictures showing the repairs made on Phase 3 near marker XX. These were taken on June 21, 2016.

On June 22 and 29, 2016 the TCEQ Houston Region Office received documentation from Blue Ridge Landfill which included photographs showing repair of cover.
