Investigation # 1368875

MSW COMPLAINT INVESTIGATION

**Blue Ridge Landfill
2200 F.M. 521, Fresno (Fort Bend County), TX 77545
Municipal Solid Waste Permit No. 1505A
MSW Complaint Investigation
Conducted on October 13, 2016**

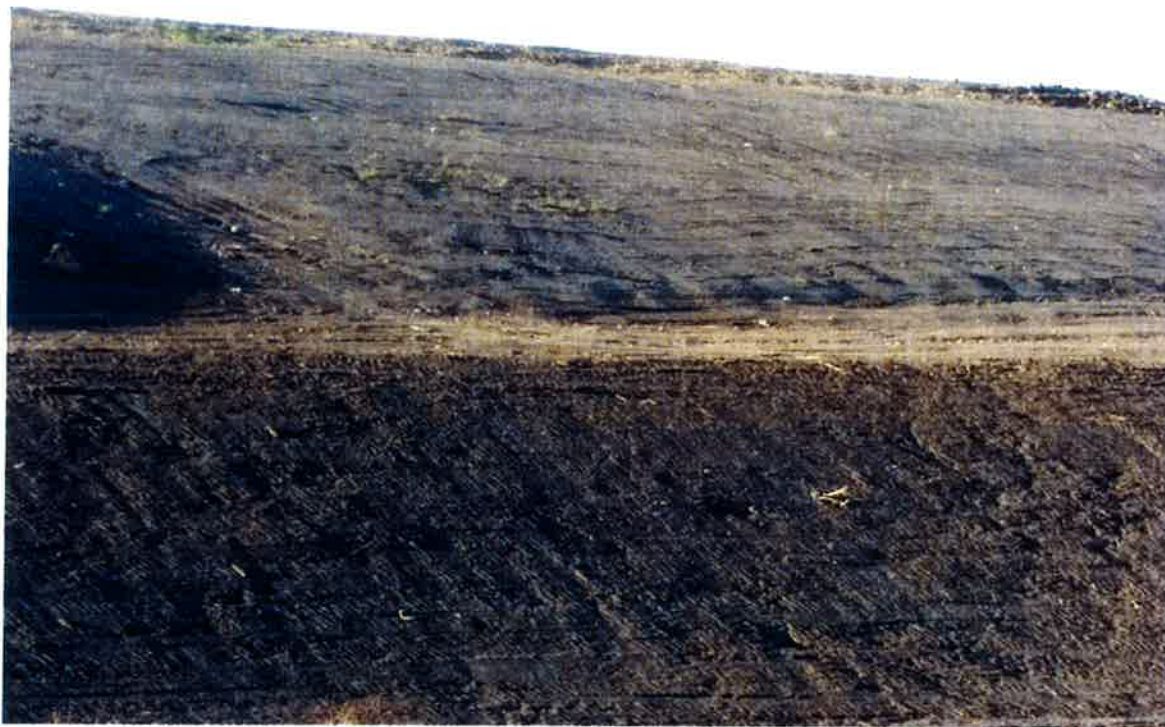
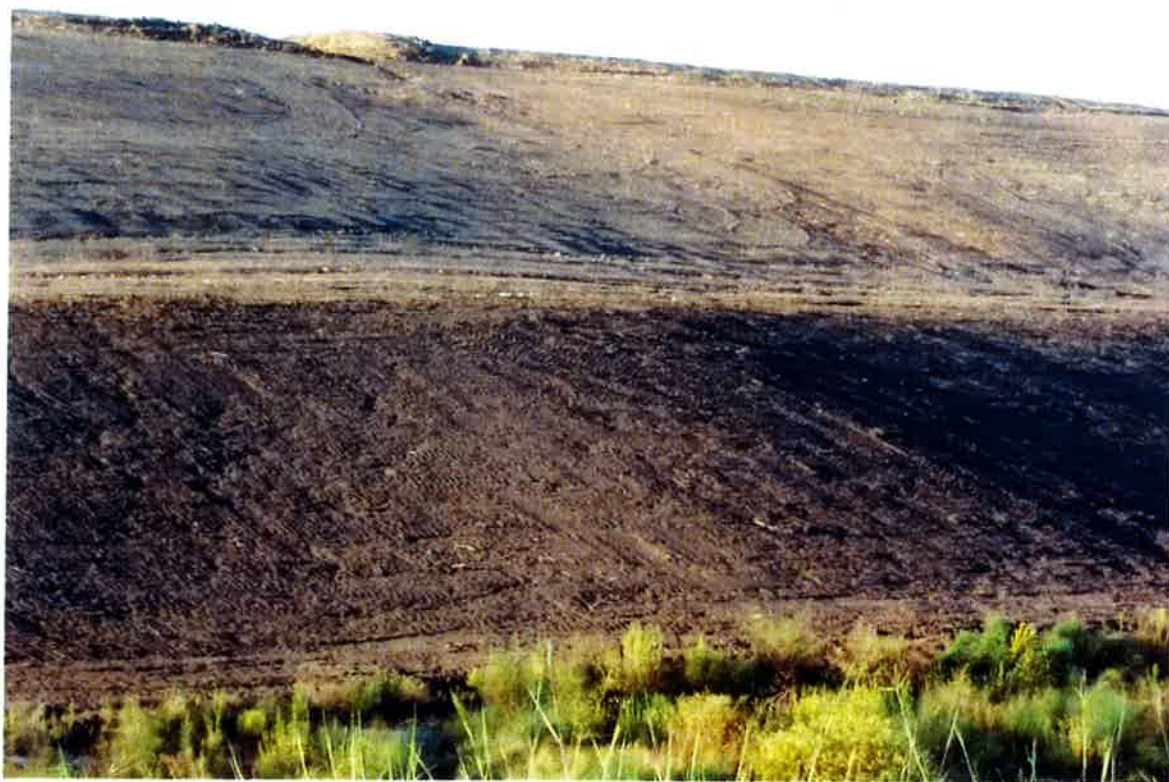
Blue Ridge LF North Slope

This letter is submitted on behalf of the Blue Ridge Landfill TX, LP (Landfill) to respond to your April 29, 2016 approval for additional time to repair erosion. The erosion occurred due to heavy rainfall on April 17 and 18, 2016, as well as 1.65 inches of rain on April 24, 2016. I have attached photos of the repaired areas that were observed as having erosion as a result of the rain events.
