MSW PA_1505A_CO_20161018_Investigation Report
Texas Commission on Environmental Quality
Investigation Report

Regulated Entity Name: BLUE RIDGE LANDFILL

<p>Investigation # 1376757</p> <p>Investigator: RICHARD BLACKNEY</p> <p>Conducted: 10/18/2016 -- 03/06/2017</p> <p>Program(s): MUNICIPAL SOLID WASTE DISPOSAL</p> <p>Investigation Type: Compliance Investigation</p> <p>Additional ID(s): 1505A</p> <p>Address: 2200 FM 521 RD, FRESNO, TX , 77545</p>	<p>Incident Numbers</p> <p>Site Classification TYPE 1</p> <p>NAIC Code: 562212</p> <p>SIC Code: 4953</p> <p>SIC Code: 1521</p> <p>Location: LOCATED ON 2200 FM 521</p> <p>Local Unit: REGION 12 - HOUSTON</p> <p>Activity Type(s): MSWCSE - On-site followup investigation MSWOTH - A focused on-site MSW compliance investigation not included under other Workplan event description.</p>
--	---

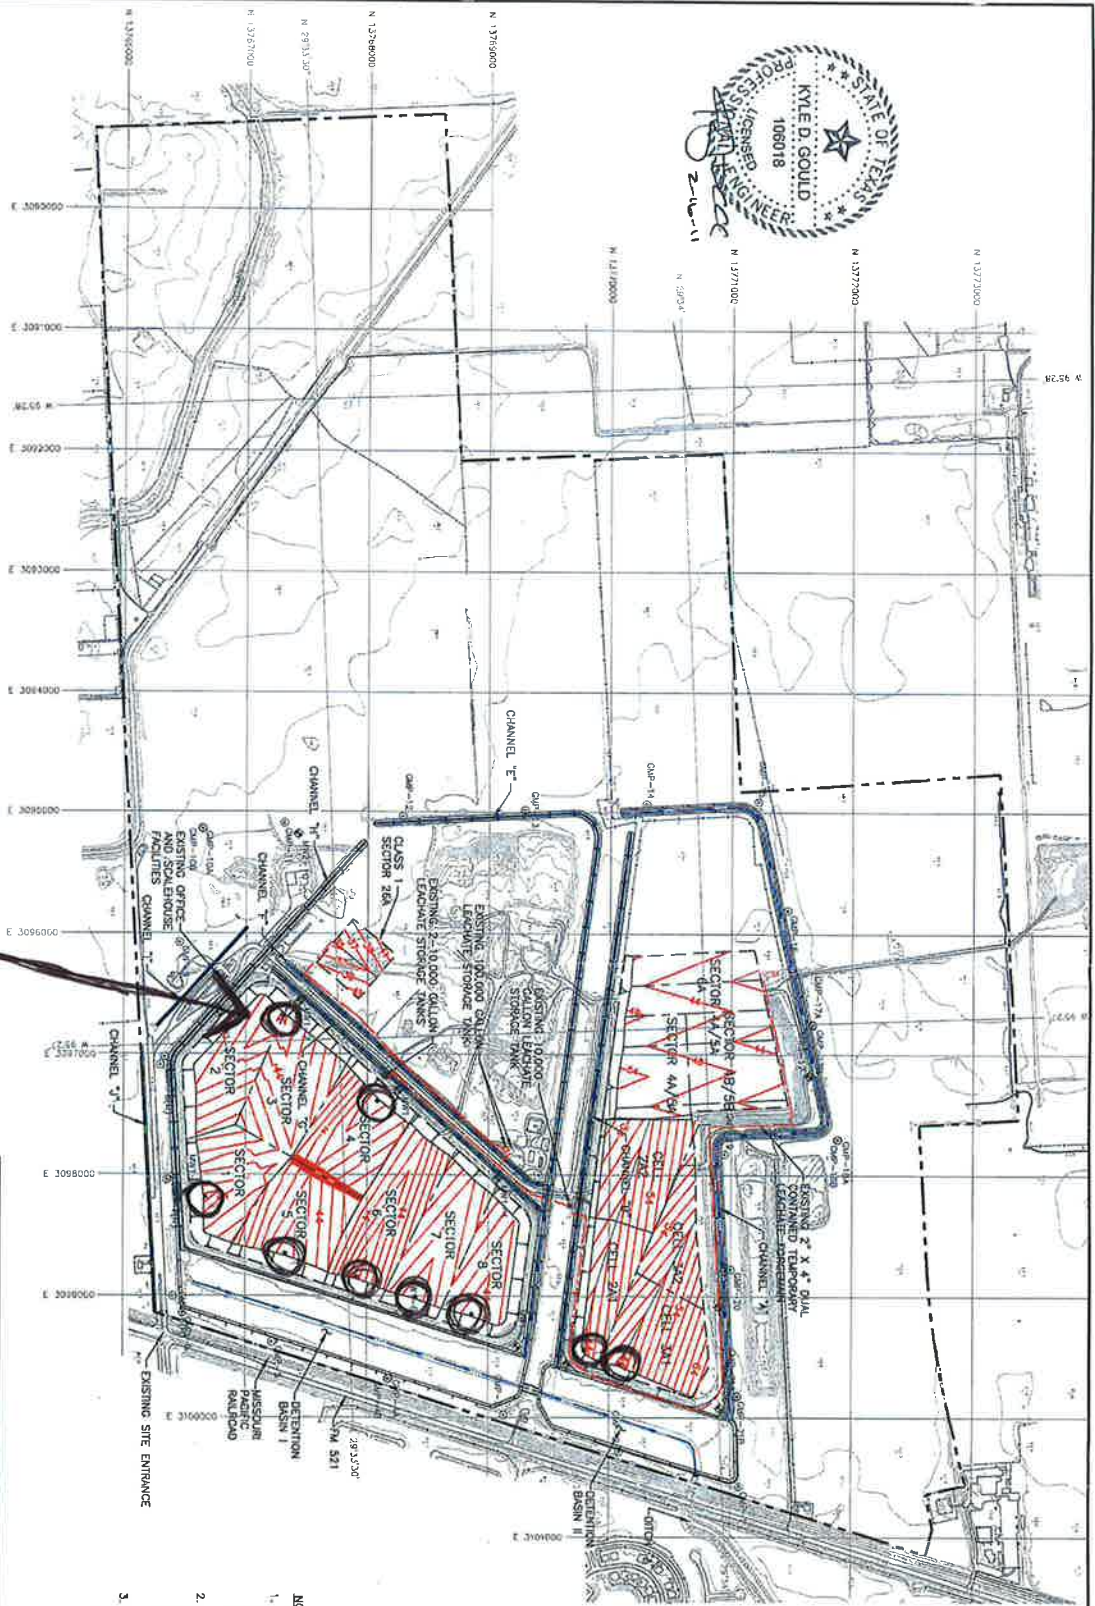
This Sump P
collects leachate from
sectors 2 and 3

Permanent leachate Sumps
are circled RB

The bottom of each cell at BRL is sloped to direct leachate to a sump. The sump collects the leachate, and has a pump and piping to convey the leachate out of the landfill. Some of the sumps are permanent sumps which will remain in their current location through the life of the landfill. Others are temporary sumps which will be moved as the landfill expands. Permanent sumps are located on the west and east sides of Phase I of the landfill, which is currently inactive. Sector sumps 1 through 8 are permanent sumps that collect leachate from Phase I. Sectors 2 and 3 drain to one sump. Two additional permanent sumps collect leachate from sectors 2A and 3A in Phase III of the landfill. A map of landfill sectors is included in Attachment 2, as are maps of the landfill as it will exist when it has expanded to its full extent. The locations of the permanent leachate sumps are identified on the first map.

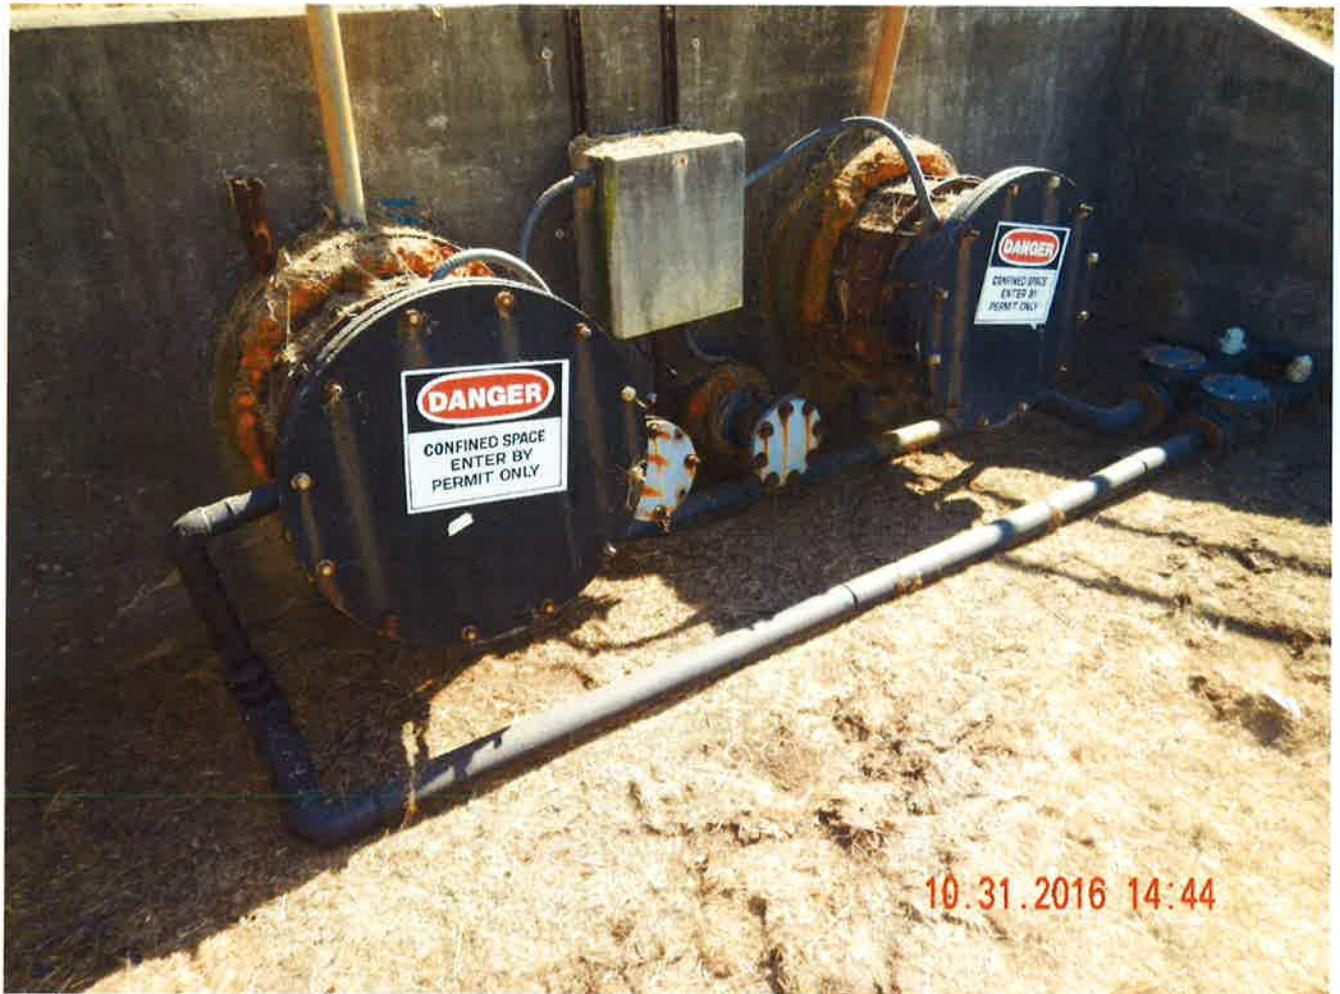
Photograph 1 of 2: Two 18" riser pipe ends visible at the sideslope of the landfill. Between them, two 6" cleanout riser pipe ends are visible. 2" pipes emerge from the 18" pipe headwall containment and run along the ground.

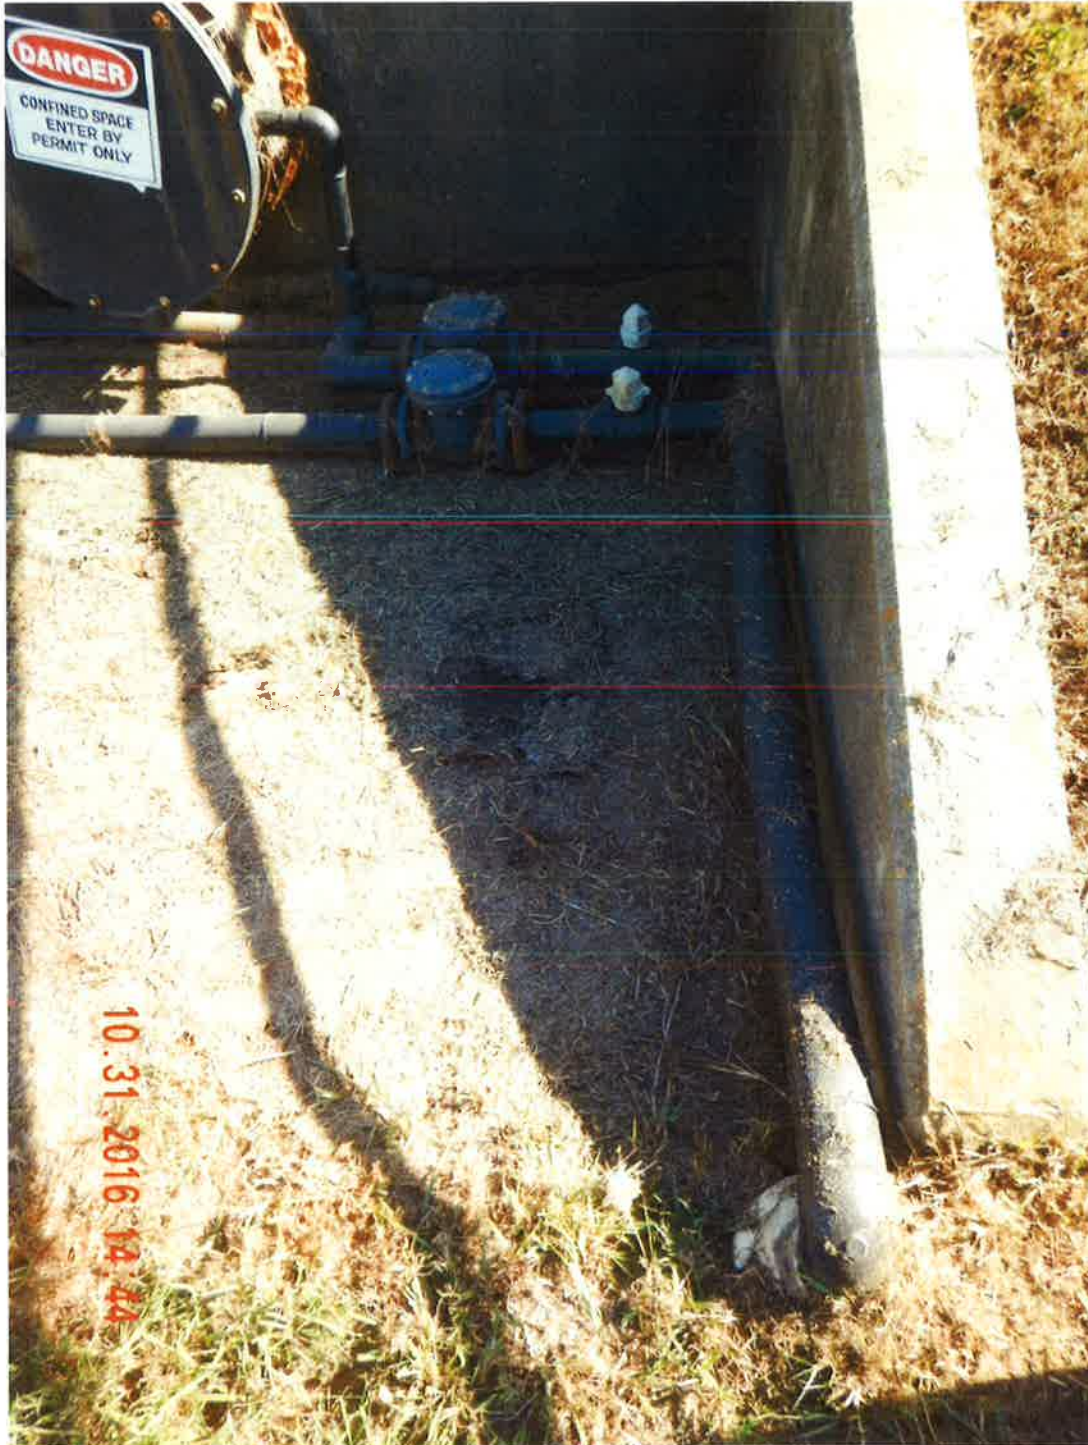
Photograph 2 of 2: Once the 2" pipe is outside of the 18" pipe headwall containment, it runs underground to reach the two leachate tanks.

Pumps located within the sumps pump leachate via a two inch pipe up the 18" riser pipe. Once the two inch pipe is outside of the 18" pipe headwall containment, it is dual contained underground to two leachate tanks.

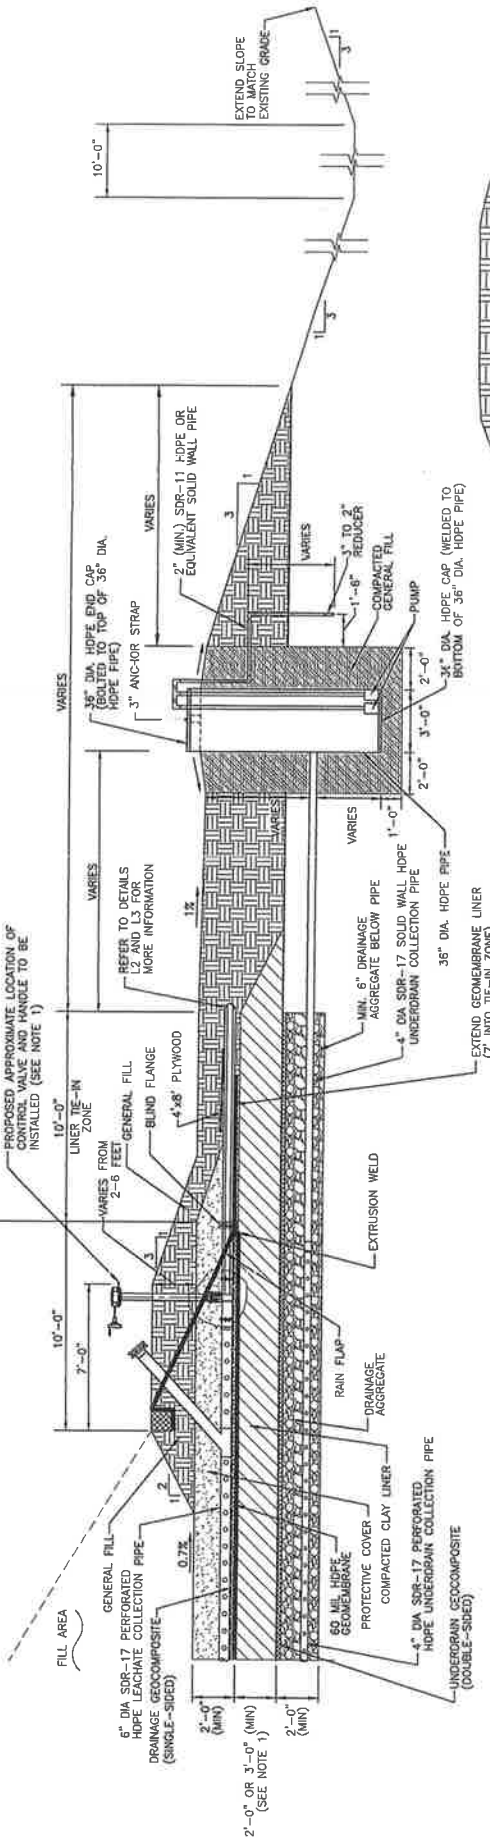
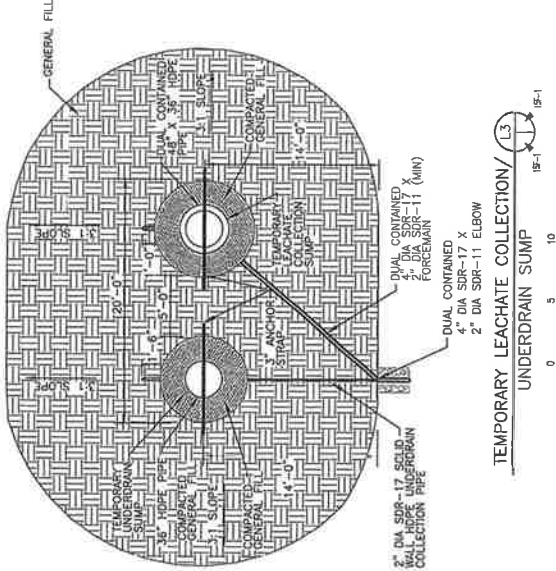
TEMPORARY UNDERDRAIN SUMP (L1) 15'-1" 19'-1" SCALE IN FEET

TEMPORARY LEACHATE COLLECTION SUMP (L2) 15'-1" 19'-1" SCALE IN FEET

TEMPORARY LEACHATE COLLECTION / UNDERDRAIN SUMP (L3) 15'-1" 19'-1" SCALE IN FEET

The temporary sumps are located outside the waste placement area. The sumps are 36"-diameter pipes oriented vertically, and are about ten feet deep. A diagram of a temporary sump is included in Attachment 6. At the time of the most recent revision of BRL's Leachate and Contaminated Water Plan (LCWP) in 2011, BRL had "temporary LCS [leachate collection sumps] and underdrain sumps in Sectors 4B/5B and 6A, respectively", but "as the site develops, additional temporary LCS and underdrain sumps may need to be constructed in the future to facilitate site operations". Since that time, temporary sumps have also collected leachate from sectors 7A, 8 and 10 in Phase III of the landfill, as well as from sector 26 in Phase II of the landfill.

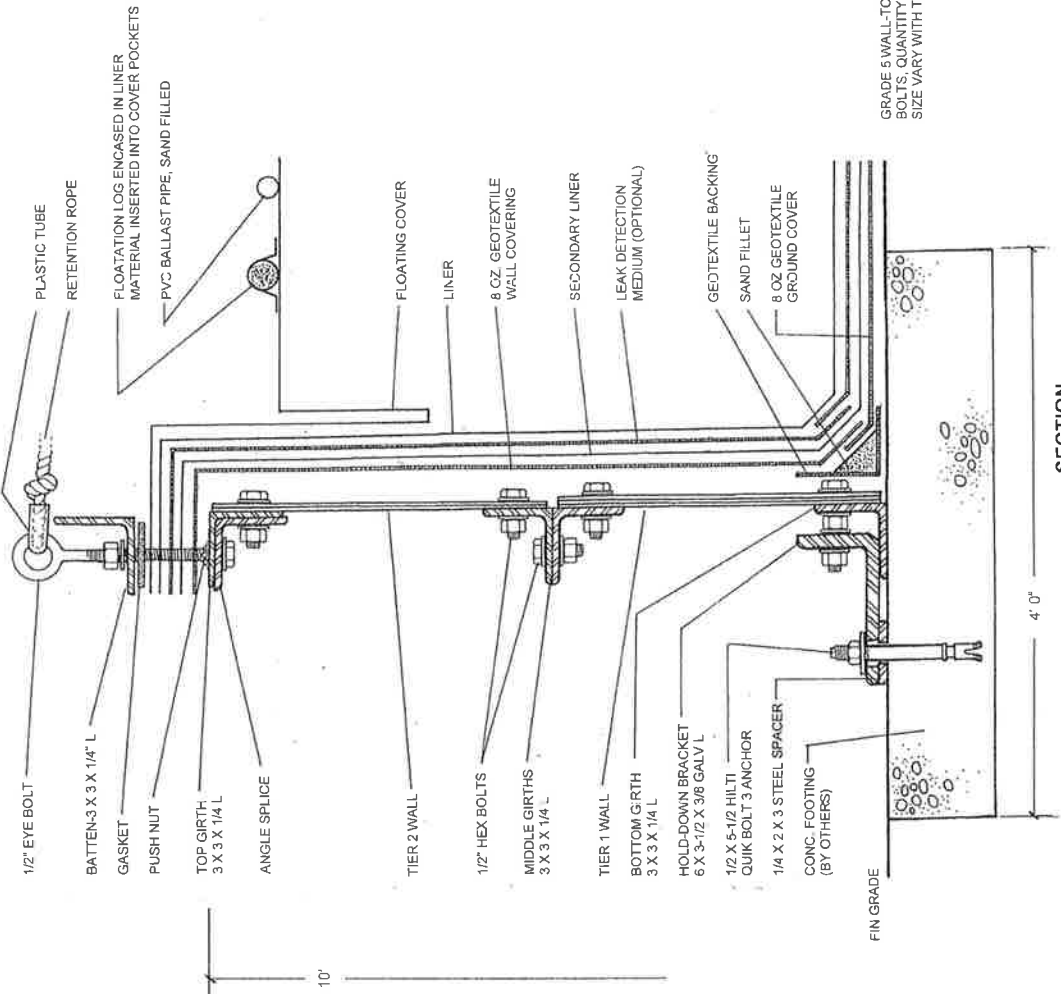
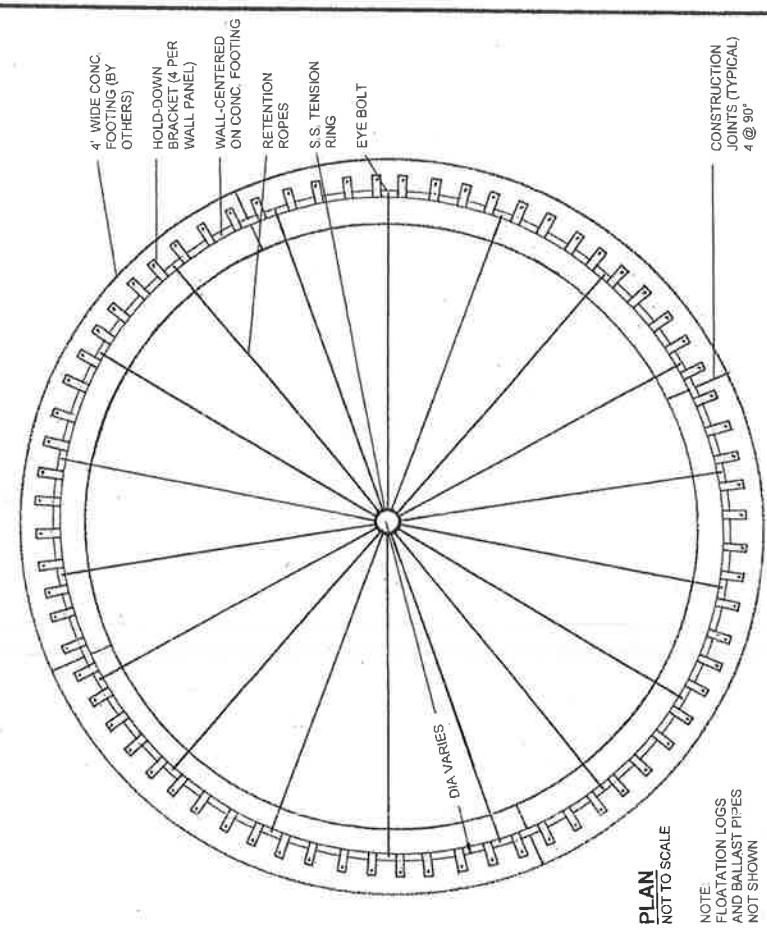
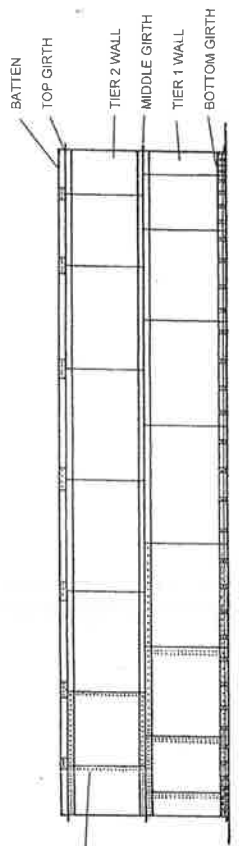
GENERAL ARRANGEMENT - 2 TIER MODUSTOR, DOUBLE LINERS, FLOATING COVER				REVISED
CONCRETE RING FOUNDATION				REVISED
DRAWN BY	CHECKED BY	SCALE	PART NO	DATE
			DWG. NO.

PLAN
NOT TO SCALE

ELEVATION
NOT TO SCALE

GRADE 5 WALL-TO-WALL
BOLTS, QUANTITY AND
SIZE VARY WITH TANK SIZE

The two leachate storage tanks each have a capacity of 107,000 gallons, for a total capacity of 214,000 gallons. The leachate storage tank is a ModuTank that has a metal "shell" with a bladder system inside. According to the facility representatives, the top of these tanks have a 2" by 2" vent with a flap in the center to prevent potential ballooning. A ModuTank drawing from the manufacturer is included in Attachment 7. For more information on the leachate tank vents, see the Additional Information section.
