# Texas Commission on Environmental Quality Investigation Report

**Regulated Entity Name: BLUE RIDGE LANDFILL**

**Investigation #** 1314675

**Program(s):** MUNICIPAL SOLID WASTE DISPOSAL

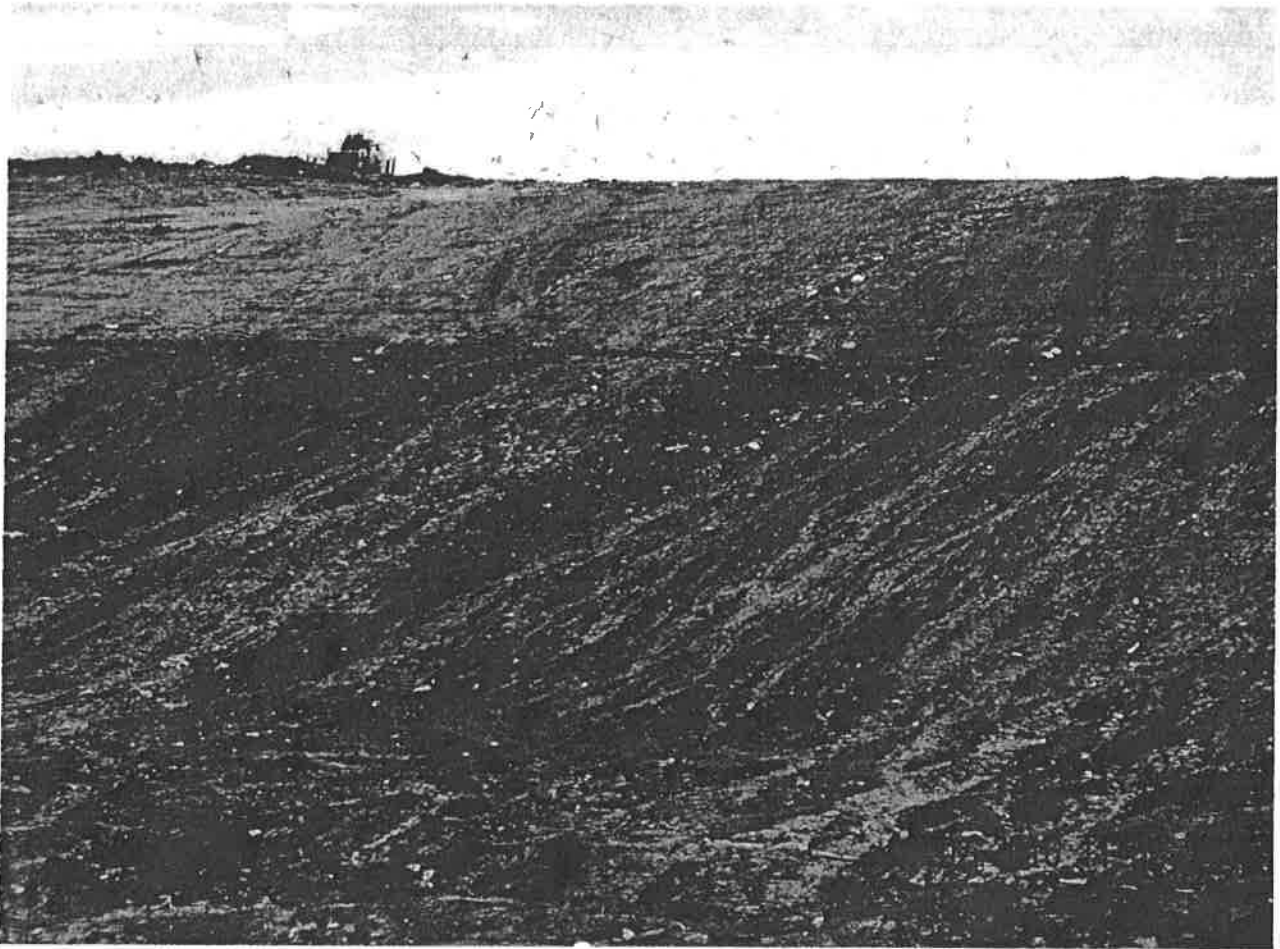
The investigators observed the area on the northern slope of the landfill where erosion of cover had previously been observed, and the cover appeared to be repaired. A photograph taken by Mr. Blackney is included in Attachment 5. However, another area of erosion was observed, and can also be seen in Attachment 5. This is discussed further in the Summary of Investigation Findings section.

Photograph 1 of 2: The erosion of cover previously observed on December 18, 2015 appeared to have been repaired.

On January 5, 2016, the facility representative sent photographs to the TCEQ showing repair of cover. On February 2, 2016, the area was observed by the investigator to have been largely repaired, but it appeared there remained some gullies where cover was eroded by more than four inches. On March 2, 2016, the area appeared to have been repaired, and the cover log from February 2016 was viewed which indicated that repair of cover was completed on February 13, 2016. However, on March 2, 2016, another area of erosion of cover was observed. Blue Ridge Landfill is requested to restore the cover material and include the date of completion of repairs in the cover log. The facility is requested to submit documentation to the TCEQ Houston Region Office to verify compliance.

**Recommended Corrective Action:** On January 5, 2016, the facility representative sent photographs to the TCEQ showing repair of cover. On February 2, 2016, the area was observed by the investigator to have been largely repaired, but it appeared there remained some gullies where cover was eroded by more than four inches. On March 2, 2016, the area appeared to have been repaired, and the cover log from February 2016 was viewed which indicated that repair of cover was completed on February 13, 2016. However, on March 2, 2016, another area of erosion of cover was observed. Blue Ridge Landfill is requested to restore the cover material and include the date of completion of repairs in the cover log. The facility is requested to submit documentation to the TCEQ Houston Region Office to verify compliance.

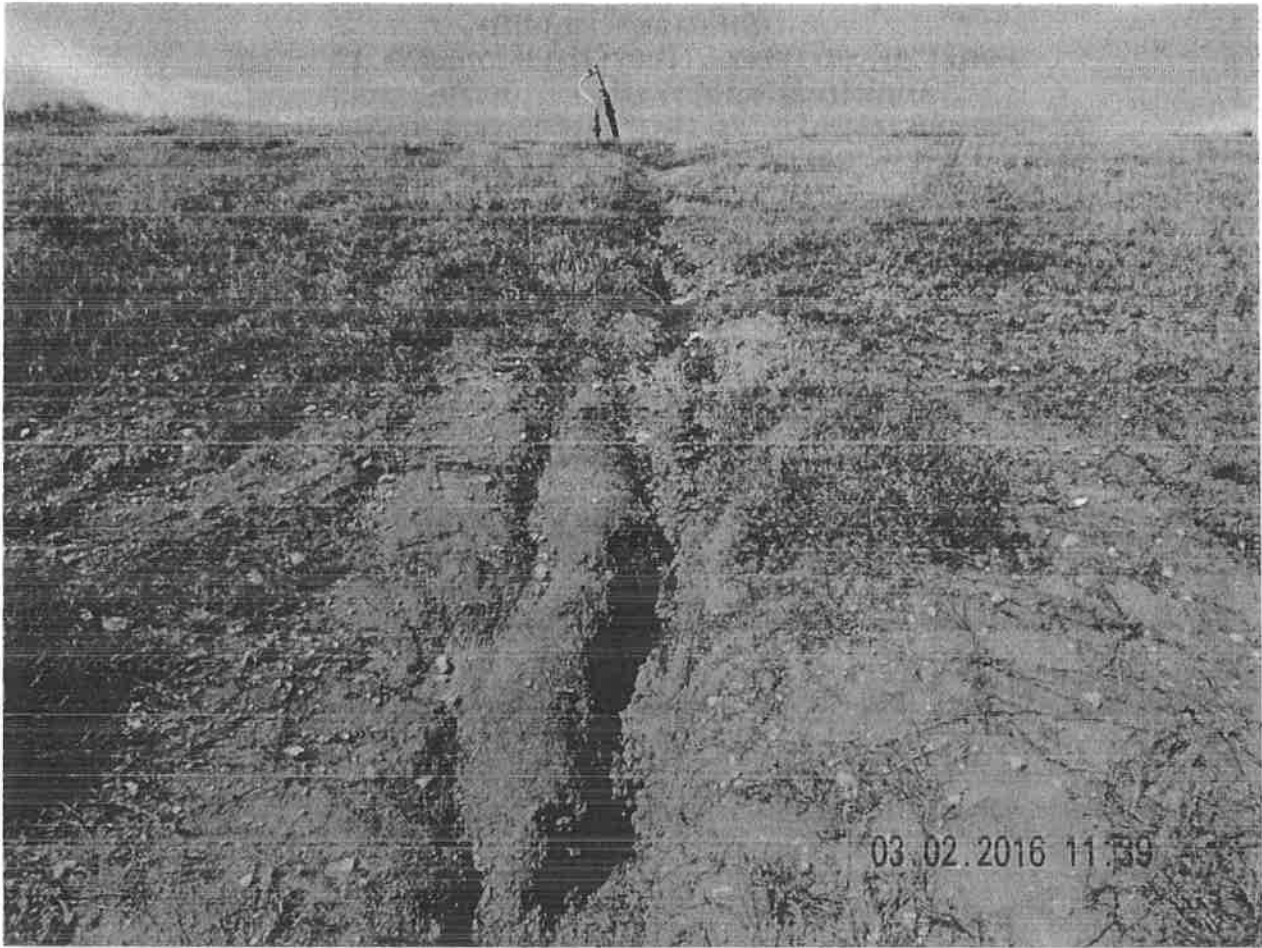
Photograph 2 of 2: Another area of erosion of cover was observed.
