AIR CP_102610102_CP_20160608_INVESTIGATION_1349162_
Texas Commission on Environmental Quality
Investigation Report

Regulated Entity Name: BLUE RIDGE LANDFILL
Regulated Entity Number: RN102610102

Investigation # 1349162 Investigator: TOM PINKSTON Conducted: 06/08/2016 -- 06/09/2016 Program(s): AIR OPERATING PERMITS Investigation Type: Compliance Investigation Additional ID(s): FG0536E 1472 Address: 2200 FM 521 RD, FRESNO, TX , 77545	Incident Numbers Site Classification MAJOR SOURCE NAIC Code: 562212 SIC Code: 4953 SIC Code: 1521 Location: LOCATED ON 2200 FM 521 Local Unit: REGION 12 - HOUSTON Activity Type(s): FIAIRODOR - AIR FIAIRODOR - FOC INV ODOR SURVEY
---	--

BLUE RIDGE LANDFILL - FRESNO

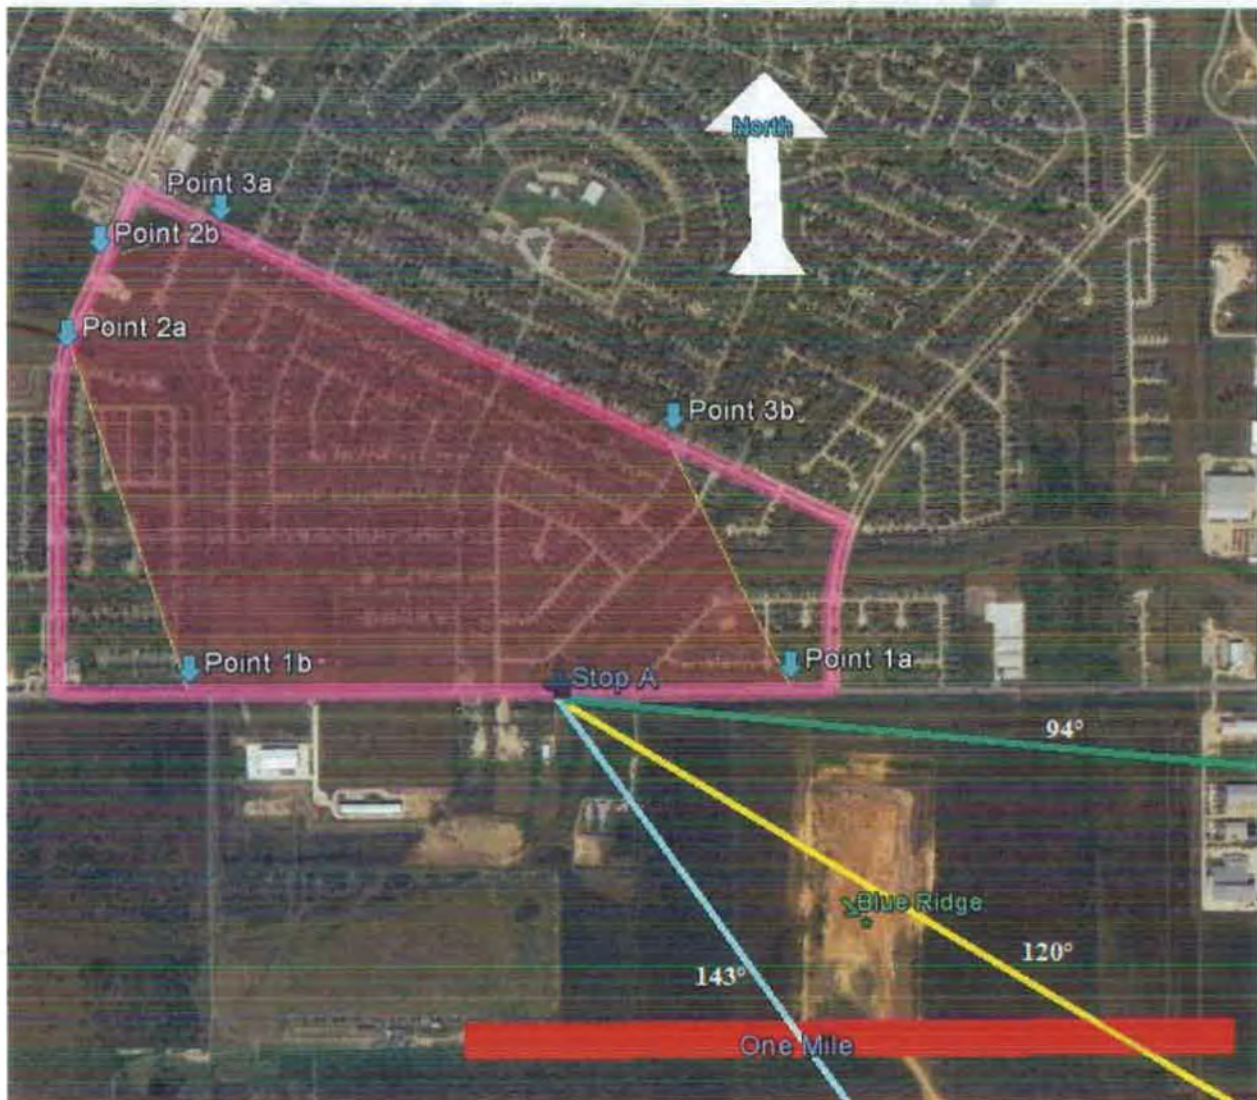
d. Stop A

- Time in area: June 8, 2016 22:15 through June 9, 2016 0:100.
- Downwind observations: During this time, this area was downwind of Blue Ridge Landfill. An odor of landfill waste was detected. Points were drawn showing where odor was detected. The area colored red represents the apparent odor plume.
- Upwind observations: No odor detected on FM 521, upwind of Blue Ridge Landfill.

The odor appeared to be most intense along McHard Road. Refer to Attachment 1 Maps, Map d. Stop A.

At 22:45 hours, the investigators stopped at a point on McHard Road which appeared near the center of the plume and in an area where the odor appeared most intense (refer to Attachment 1 Maps, Map d. Stop A). Winds were approximately 1 to 4 mph east southeast ranging from 94° to 143° with a mean wind direction of 120°. Given the investigators' location downwind of Blue Ridge and upwind of most other industrial sites, the source of the odor appeared to be Blue Ridge. An offensive odor associated with landfill waste was detected; however, anytime the odor was detected, that odor would quickly dissipate and would remain undetectable for more than 15 minutes before returning again. The greatest duration of the odor was 5 minutes. The greatest one-minute intensity during this time was moderate. The greatest 10-minute weighted average of the odor intensity was very light. The odor was characterized as an offensive odor. The TCEQ's Odor Complaint Investigation Procedures and applicable

Frequency Intensity Duration Offensiveness (FIDO) Chart notes that an offensive odor with a one-minute reading of moderate intensity would not constitute a nuisance condition with a daily frequency and that a very light intensity would require a four-hour duration with a daily frequency; therefore, according to the TCEQ's Odor Complaint Investigation Procedures, the odor detected at Stop A did not constitute a nuisance odor.

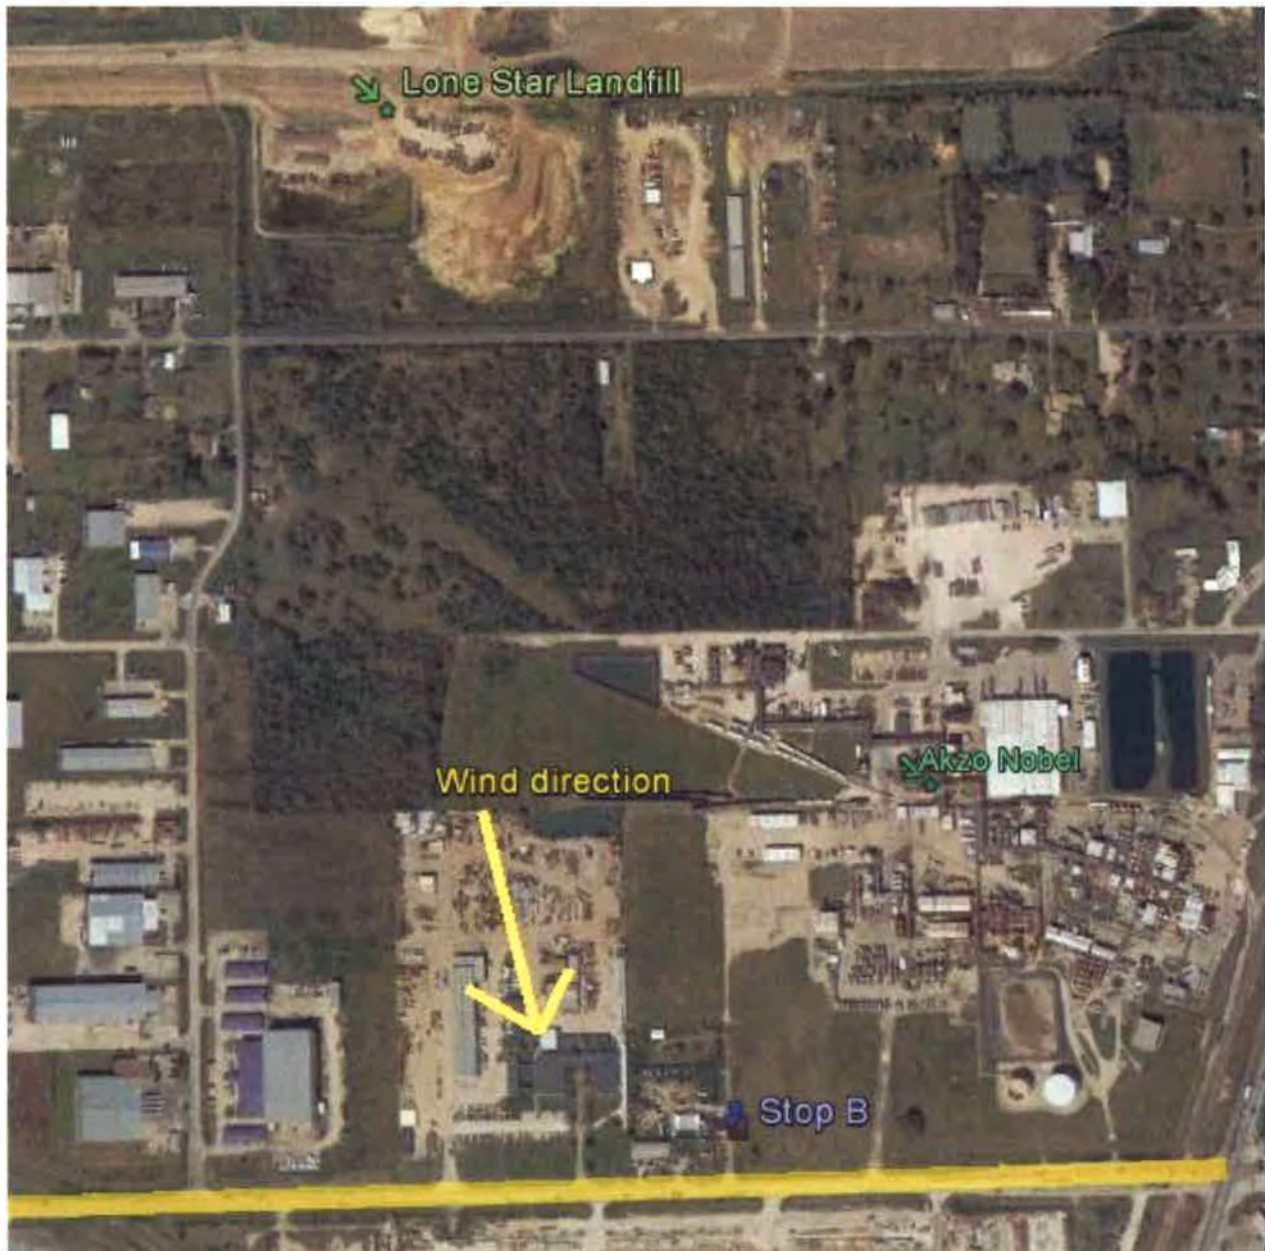
e. Stop B

- Time in area: June 9, 2016 03:15 – 04:20 hrs
- Downwind observations: A hydrogen sulfide odor was detected.
- Upwind observations: After the one hour odor intensity time log no odor could be detected upwind of the site or at this location so the source could not be confirmed; therefore the area upwind could not be determined.

At 03:15 hours, the investigators drove west along McHard Road using Route 1. A very strong, highly offensive odor associated with hydrogen sulfide was detected at Stop B (Attachment 1 Maps, Map c. Stop B). Predominate winds were observed to be northeast placing the investigators directly downwind of Lone Star Landfill and slightly west of upwind from Akzo Nobel. The investigators were upwind of Blue Ridge at this time. An Investigator's Odor Intensity Time Log was conducted for one hour starting at 03:20 hrs (Attachment 2, Odor Logs). The highest 1-minute odor intensity was very strong. The maximum 10-minute weighted average intensity was moderate. The weighted one hour average intensity was light. At 04:40 hours, the investigators drove to Route 5, which goes north on West Drive from McHard Road and separates several industrial areas that are located on the west side of Route 5. No odor was detected. The investigators then drove down Route 4 placing the investigators upwind of Akzo Nobel and downwind of Lone Star. No odor was detected. At 05:00 hrs, the investigators drove back to Stop B and no odor was detected. The odor that was detected at Stop B appears to have stopped after the initial survey, preventing the investigators from determining the source. This is a single occurrence of a highly offensive odor with a 1-hour weighted average of light from an unknown source north of McHard Road. Based on TCEQ's Odor Complaint Investigation Procedures and the applicable FIDO Chart the odor would need to be present for one hour with a weighted average intensity of very strong to constitute a nuisance odor; therefore, this odor does not constitute a nuisance condition.
