Re: Investigation Request at:  
Blue Ridge Landfill, 2200 FM 521 Rd, Fresno (Fort Bend County)  
Regulated Entity No.: 102610102  
TCEQ MSW Permit No.: 1505A  
Investigation No.: 1518011

MSW PA\_1505A\_CP\_20180920\_Investigation  
**Texas Commission on Environmental Quality**  
**Investigation Report**

**Blue Ridge Landfill  
2200 F.M. 521, Fresno (Fort Bend County), TX 77545  
Municipal Solid Waste Permit No. 1505A  
MSW Complaint Investigation  
Conducted on September 20, 2018**

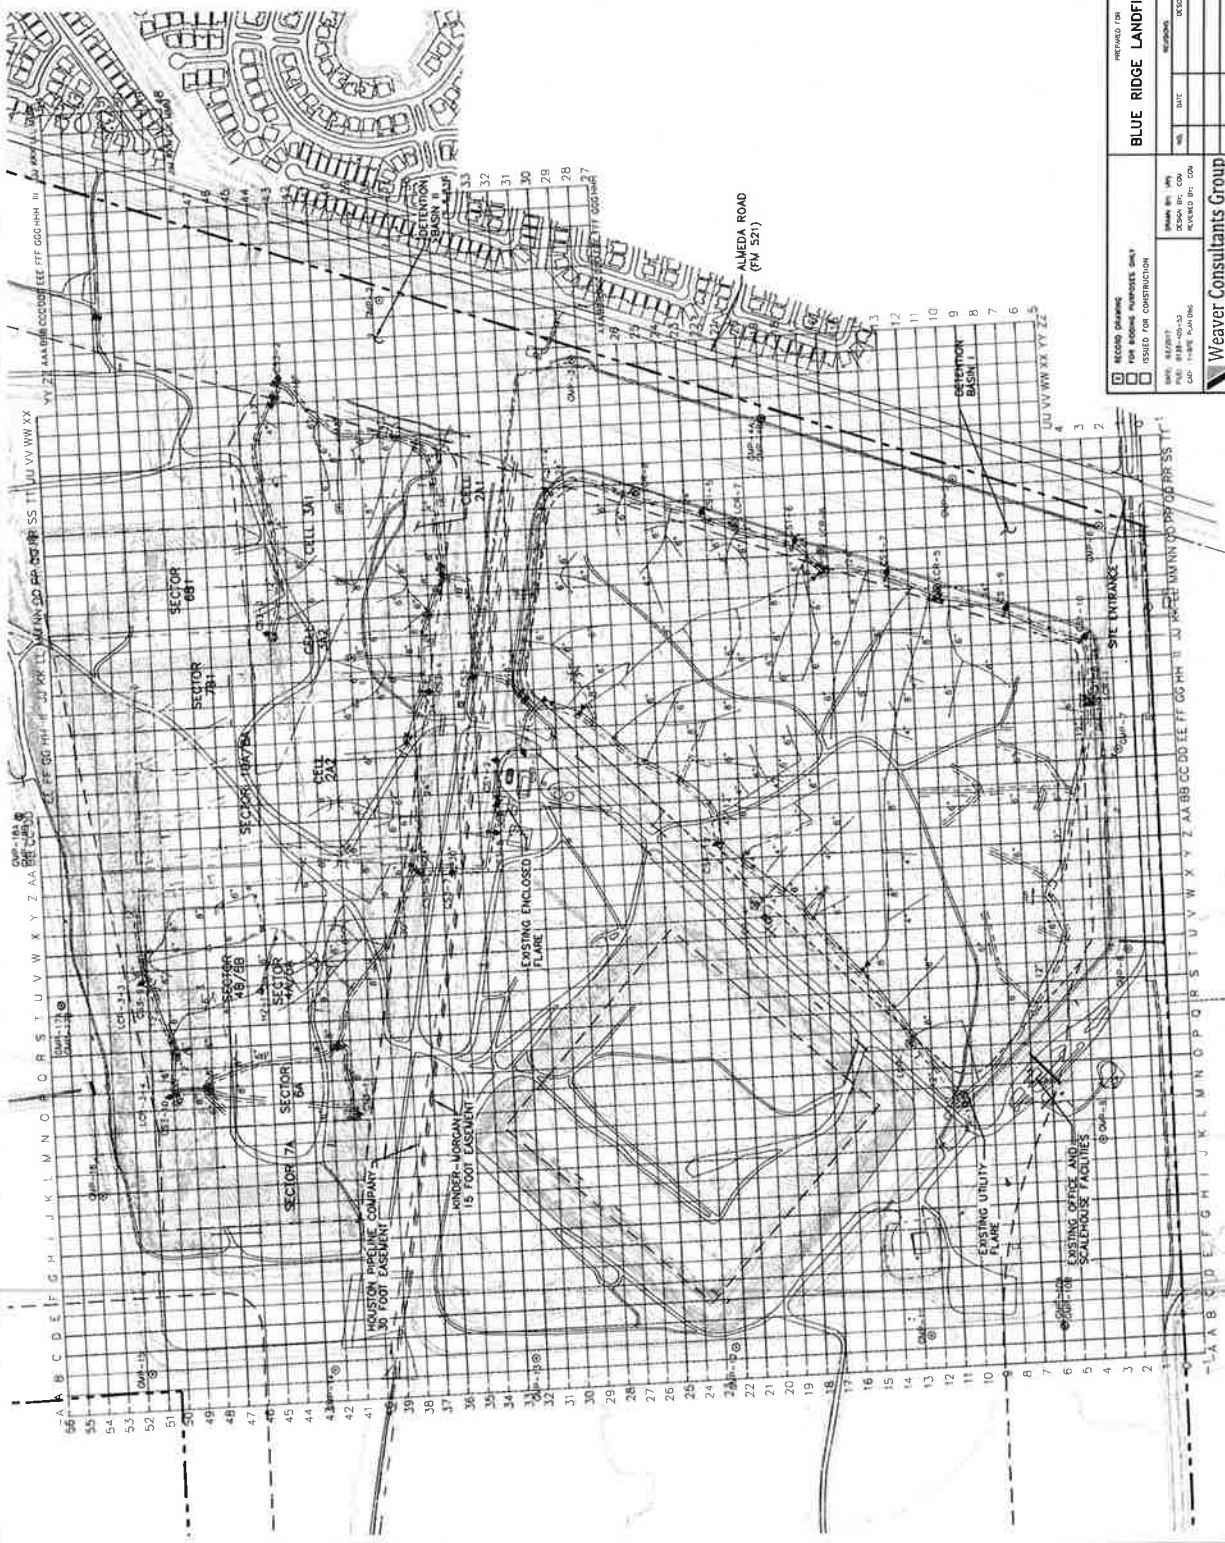
Per your letter dated July 11, 2018 approving additional time to repair erosion, Blue Ridge Landfill, TX, LP ("Blue Ridge") is providing the TCEQ Region 12 office with the ninth weekly progress in implementing the erosion corrective action. During week 9 (9/11/2018 – 9/16/2018), Blue Ridge did not complete repairs within the erosion extension areas because of rain out.

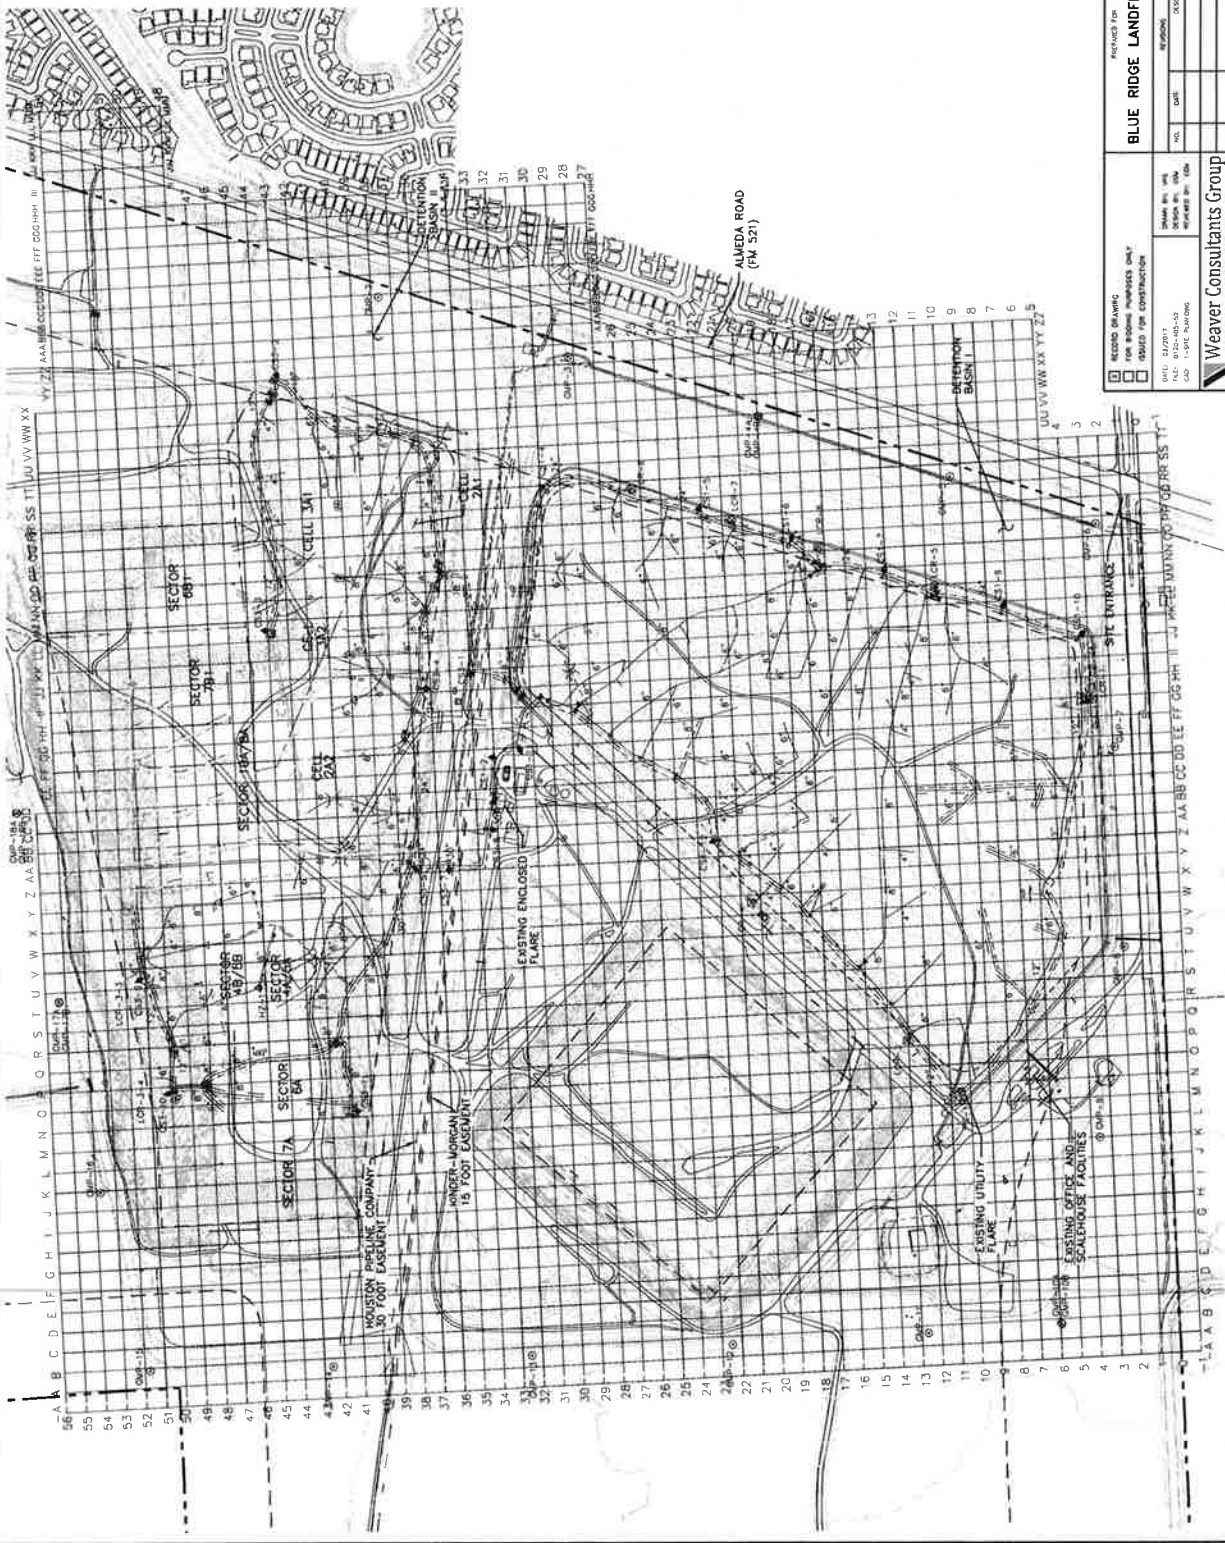
Per your letter dated July 11, 2018 approving additional time to repair erosion, Blue Ridge Landfill, TX, LP ("Blue Ridge") is providing the TCEQ Region 12 office with the tenth weekly progress in implementing the erosion corrective action. During week 10 (9/17/2018 – 9/25/2018), Blue Ridge did not complete repairs within the erosion extension areas because of rain out.
