Re: Investigation Request at:
Blue Ridge Landfill, 2200 FM 521 Rd, Fresno (Fort Bend County), TX 77545-8214
TCEQ MSW Permit No.: 1505A
Investigation No.: 1507072

MSW PA_1505A_CP_20180807_Investigation
Texas Commission on Environmental Quality
Investigation Report

**Blue Ridge Landfill
2200 F.M. 521, Fresno (Fort Bend County), TX 77545
Municipal Solid Waste Permit No. 1505A
MSW Complaint Investigation
Conducted on August 7, 2018**

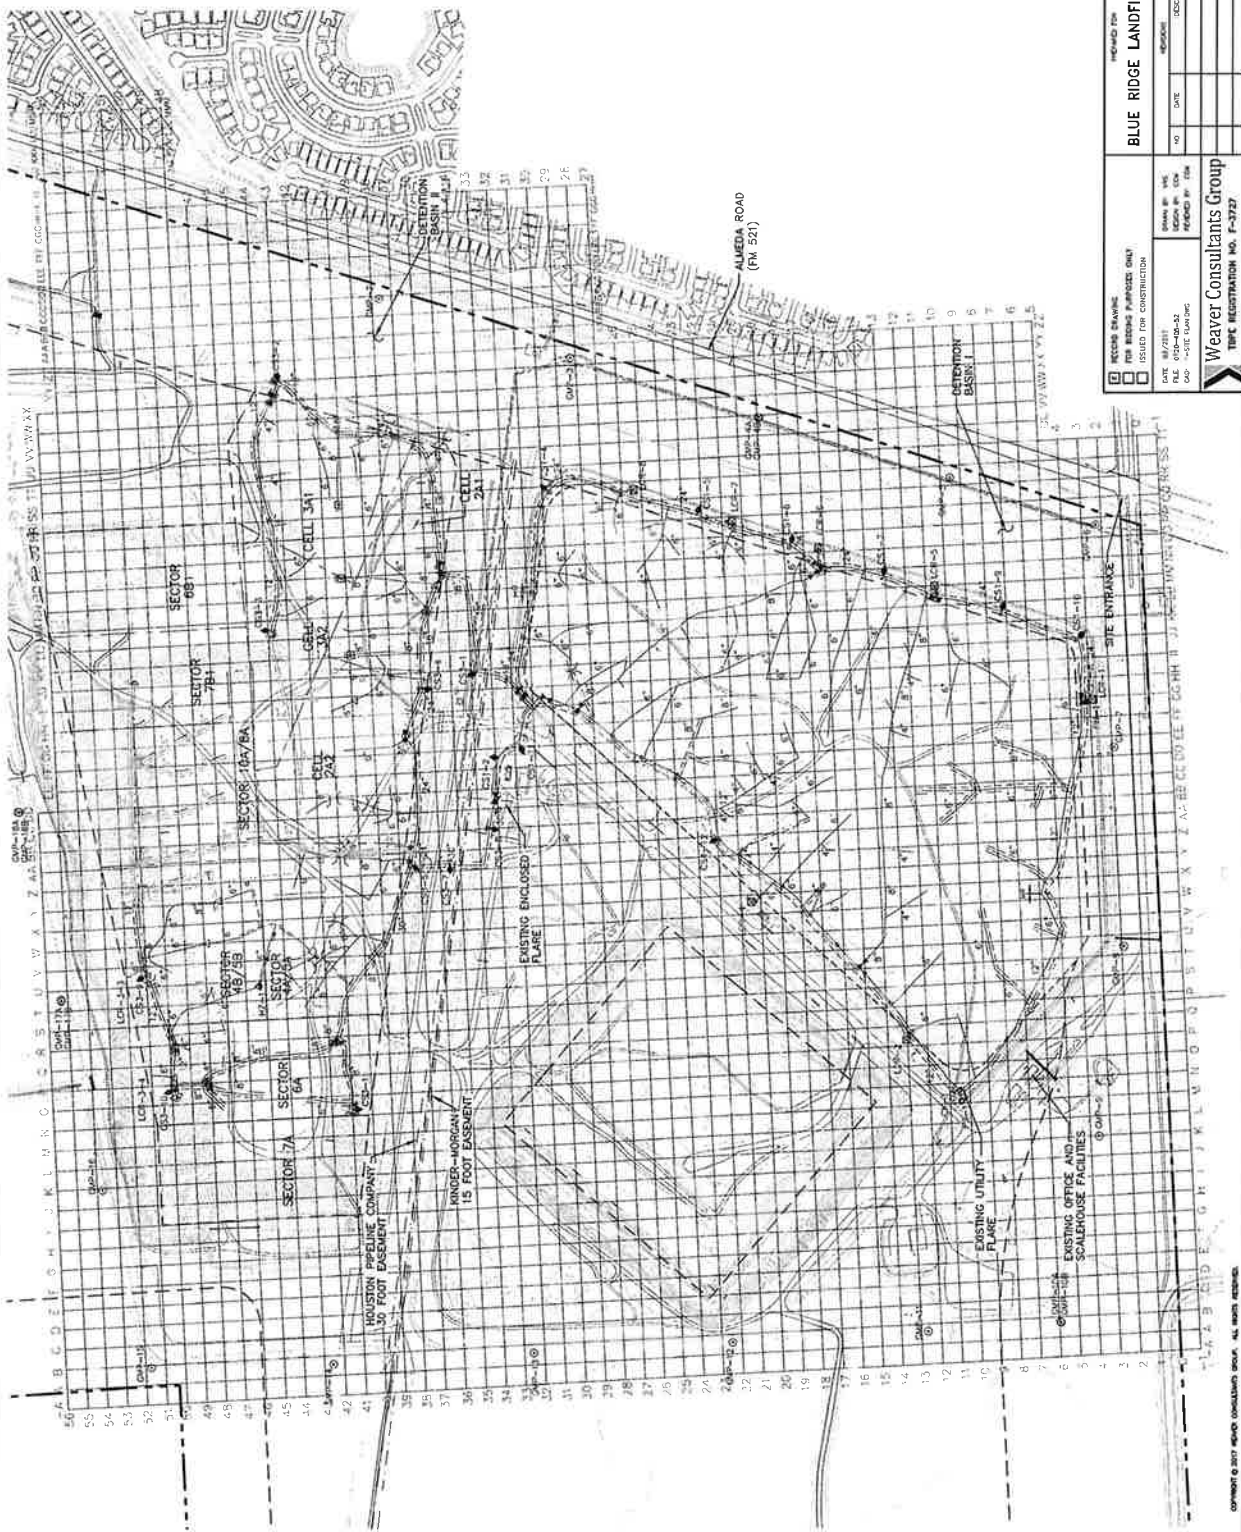
Per your letter dated July 11, 2018 approving additional time to repair erosion, Blue Ridge Landfill, TX, LP ("Blue Ridge") is providing the TCEQ Region 12 office with the second weekly progress in implementing the erosion corrective action. During week 2 (7/19/2018 - 7/25/2018), Blue Ridge completed repairs on the north slope of Phase 3 between grid markers LL-QQ and 51-55, and between WW-ZZ and 51-55.

During the site investigation, the investigator noted that the repairs had been completed between grid markers LL-QQ and 51-55, and between WW-ZZ and 51-55 by restoring cover material and grading.

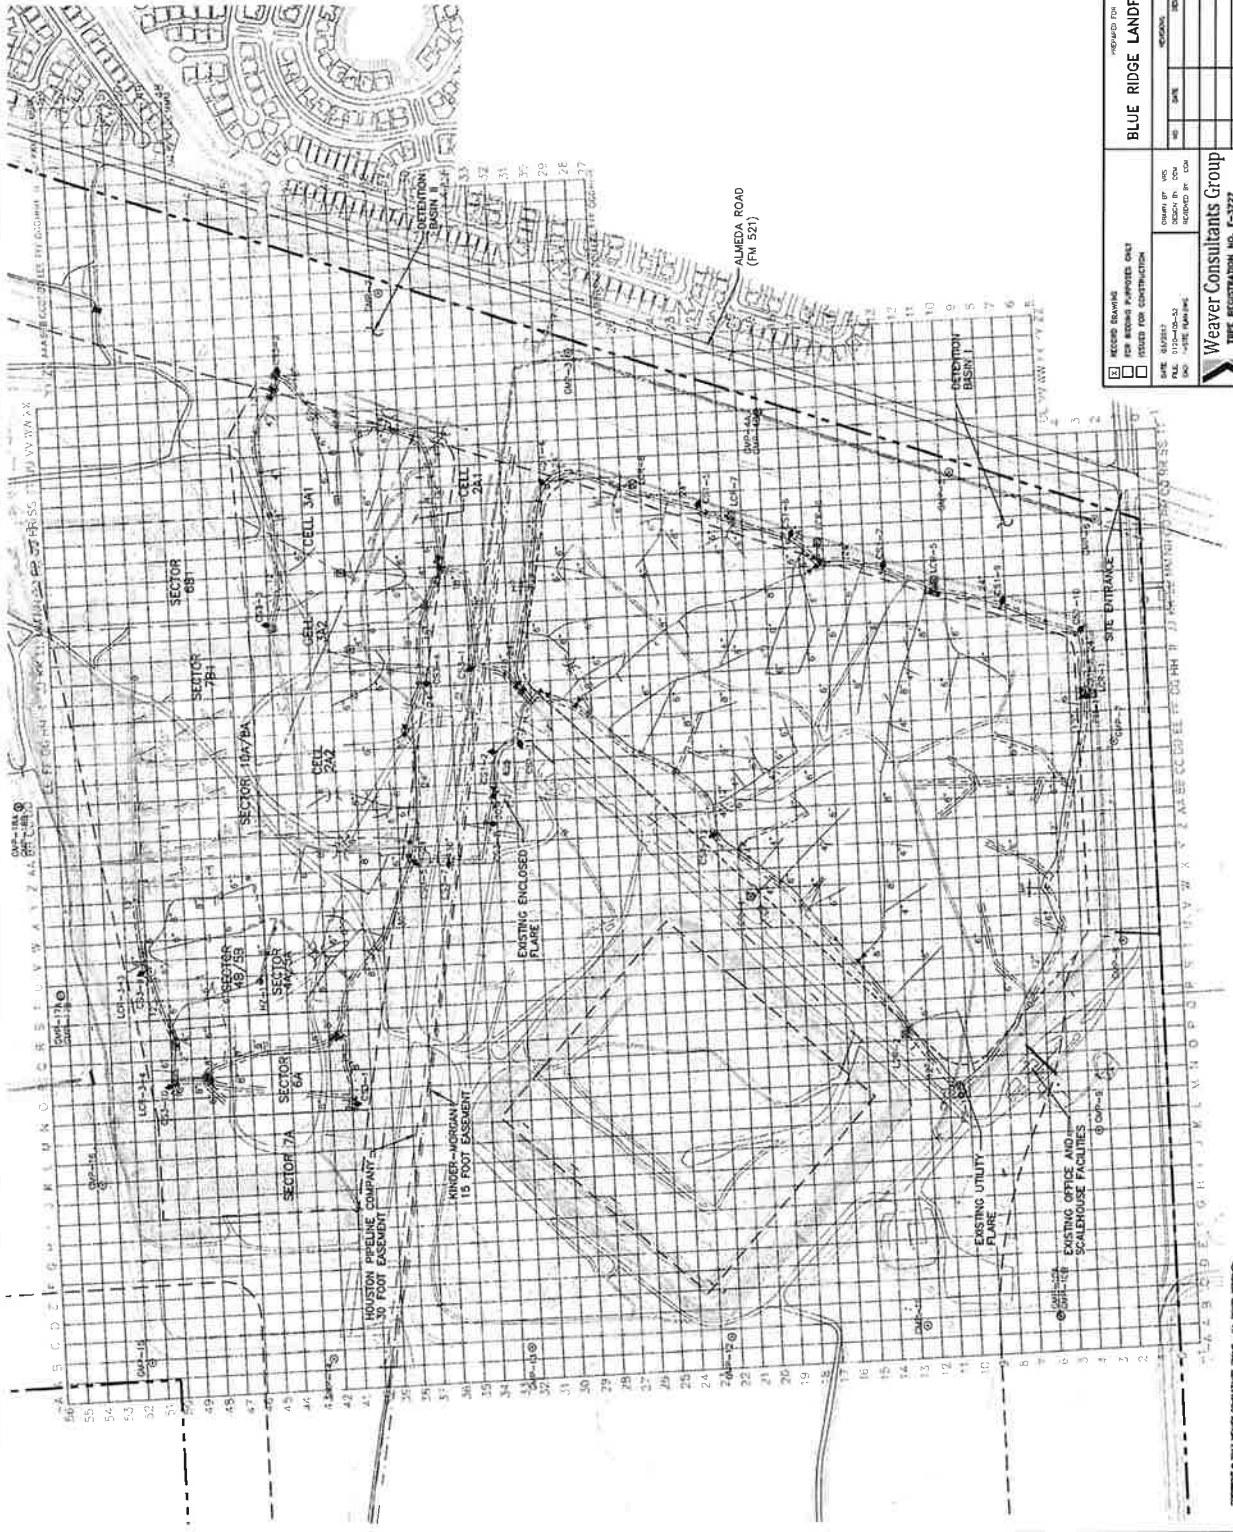
Per your letter dated July 11, 2018 approving additional time to repair erosion, Blue Ridge Landfill, TX, LP ("Blue Ridge") is providing the TCEQ Region 12 office with the third weekly progress in implementing the erosion corrective action. During week 3 (7/26/2018 - 8/2/2018), Blue Ridge completed repairs on the south slope of Phase 3 between grid markers Y-DD and 37-41, and between T-Y and 37-41.

On August 9, 2018, a letter (Attachment 4) was received from BRL, dated August 3, 2018. According to the letter, BRL completed repairs on the south slope of Phase 3 between grid markers Y-DD and 37-41, and between T-Y and 37-41.
