Re: Investigation Request at:
Blue Ridge Landfill, 2200 FM 521 Rd, Fresno (Fort Bend County), TX 77545-8214
TCEQ MSW Permit No.: 1505A
Investigation No.: 1511864

MSW PA_1505A_C1_20180822_Investigation
Texas Commission on Environmental Quality
Investigation Report

**Blue Ridge Landfill
2200 F.M. 521, Fresno (Fort Bend County), TX 77545
Municipal Solid Waste Permit No. 1505A
MSW Complaint Investigation
Conducted on August 22, 2018**

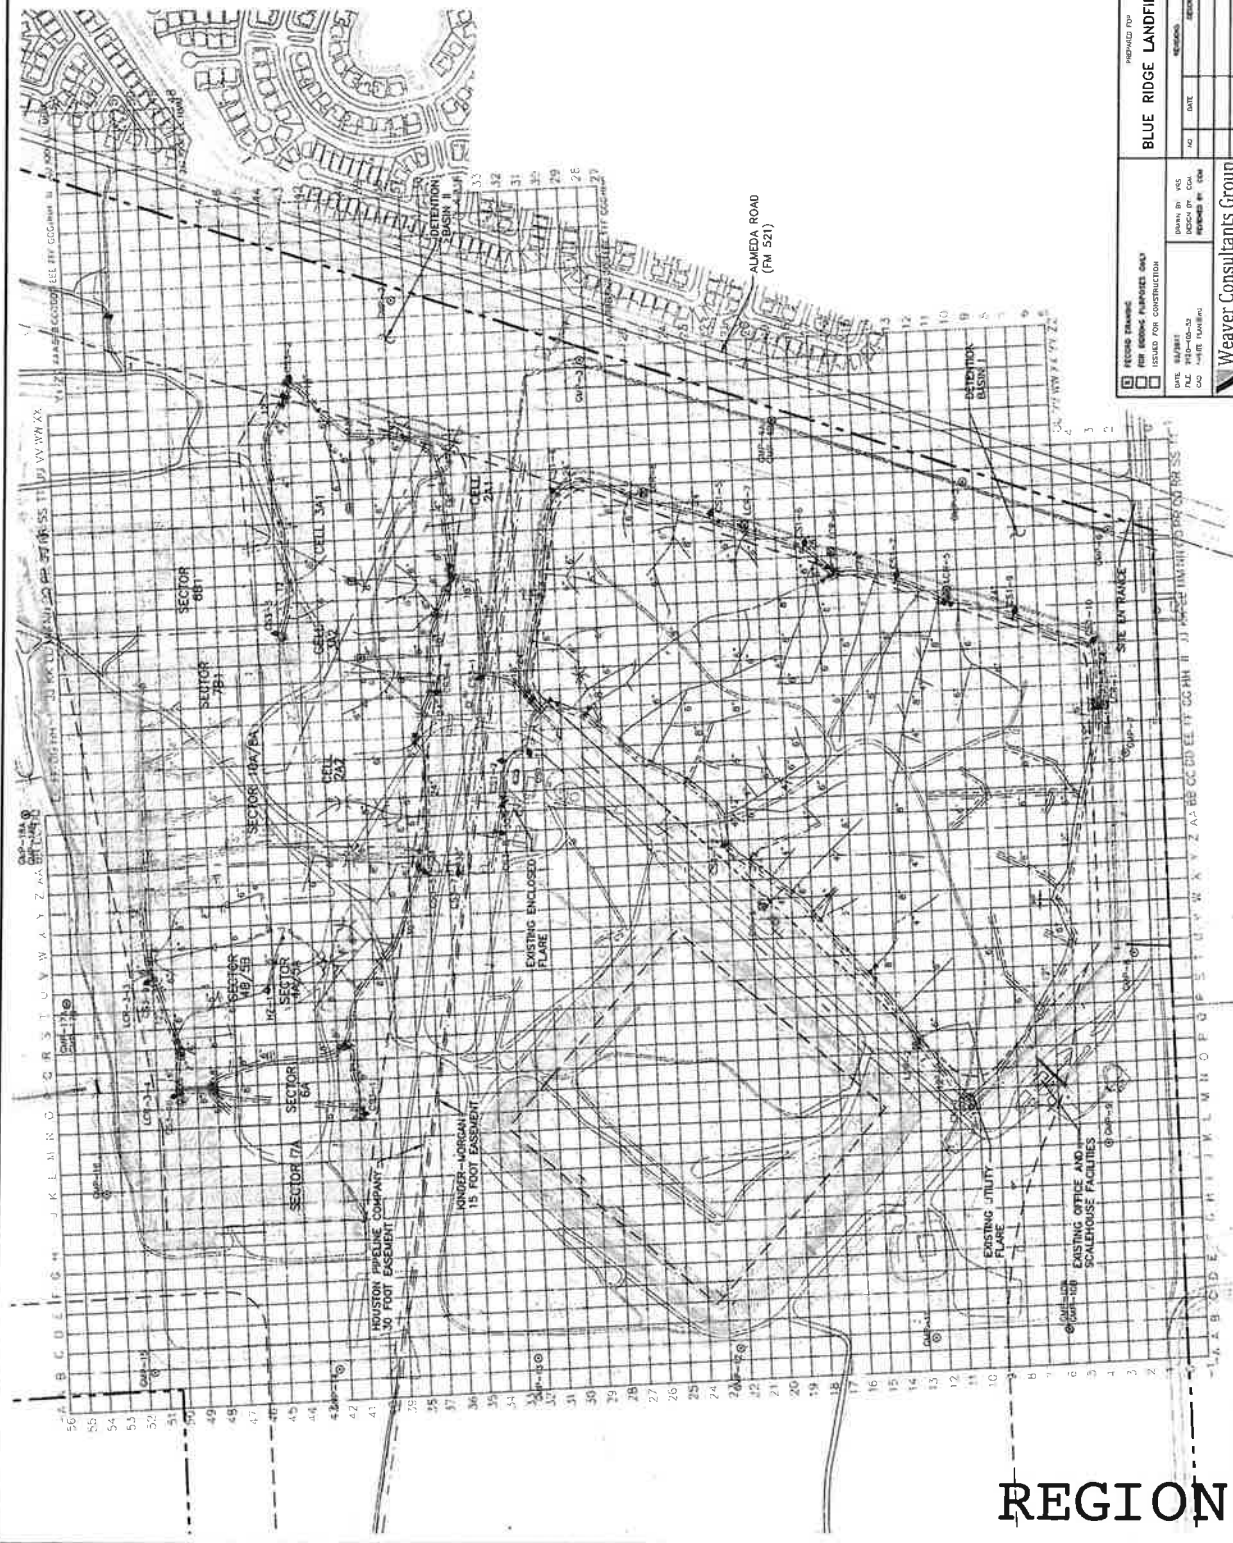
Per your letter dated July 11, 2018 approving additional time to repair erosion, Blue Ridge Landfill, TX, LP ("Blue Ridge") is providing the TCEQ Region 12 office with the fifth weekly progress in implementing the erosion corrective action. During week 4 (8/12/2018 - 8/19/2018), Blue Ridge completed repairs on the north slope of Phase 3 between grid markers SS-YY and 48-50, and between SS-YY and 44-48.

On August 23, 2018, a letter (Attachment 4) was received from BRL, dated August 20, 2018, regarding the facility's progress to repair erosion. According to the letter, BRL completed repairs on the north slope of Phase 3 between grid markers SS-YY and 48-50, and between SS-YY and 44-48.

During the site investigation, the investigator noted that the repairs had been completed between grid markers SS-YY and 48-50, and between SS-YY and 44-48 by restoring cover material and grading.

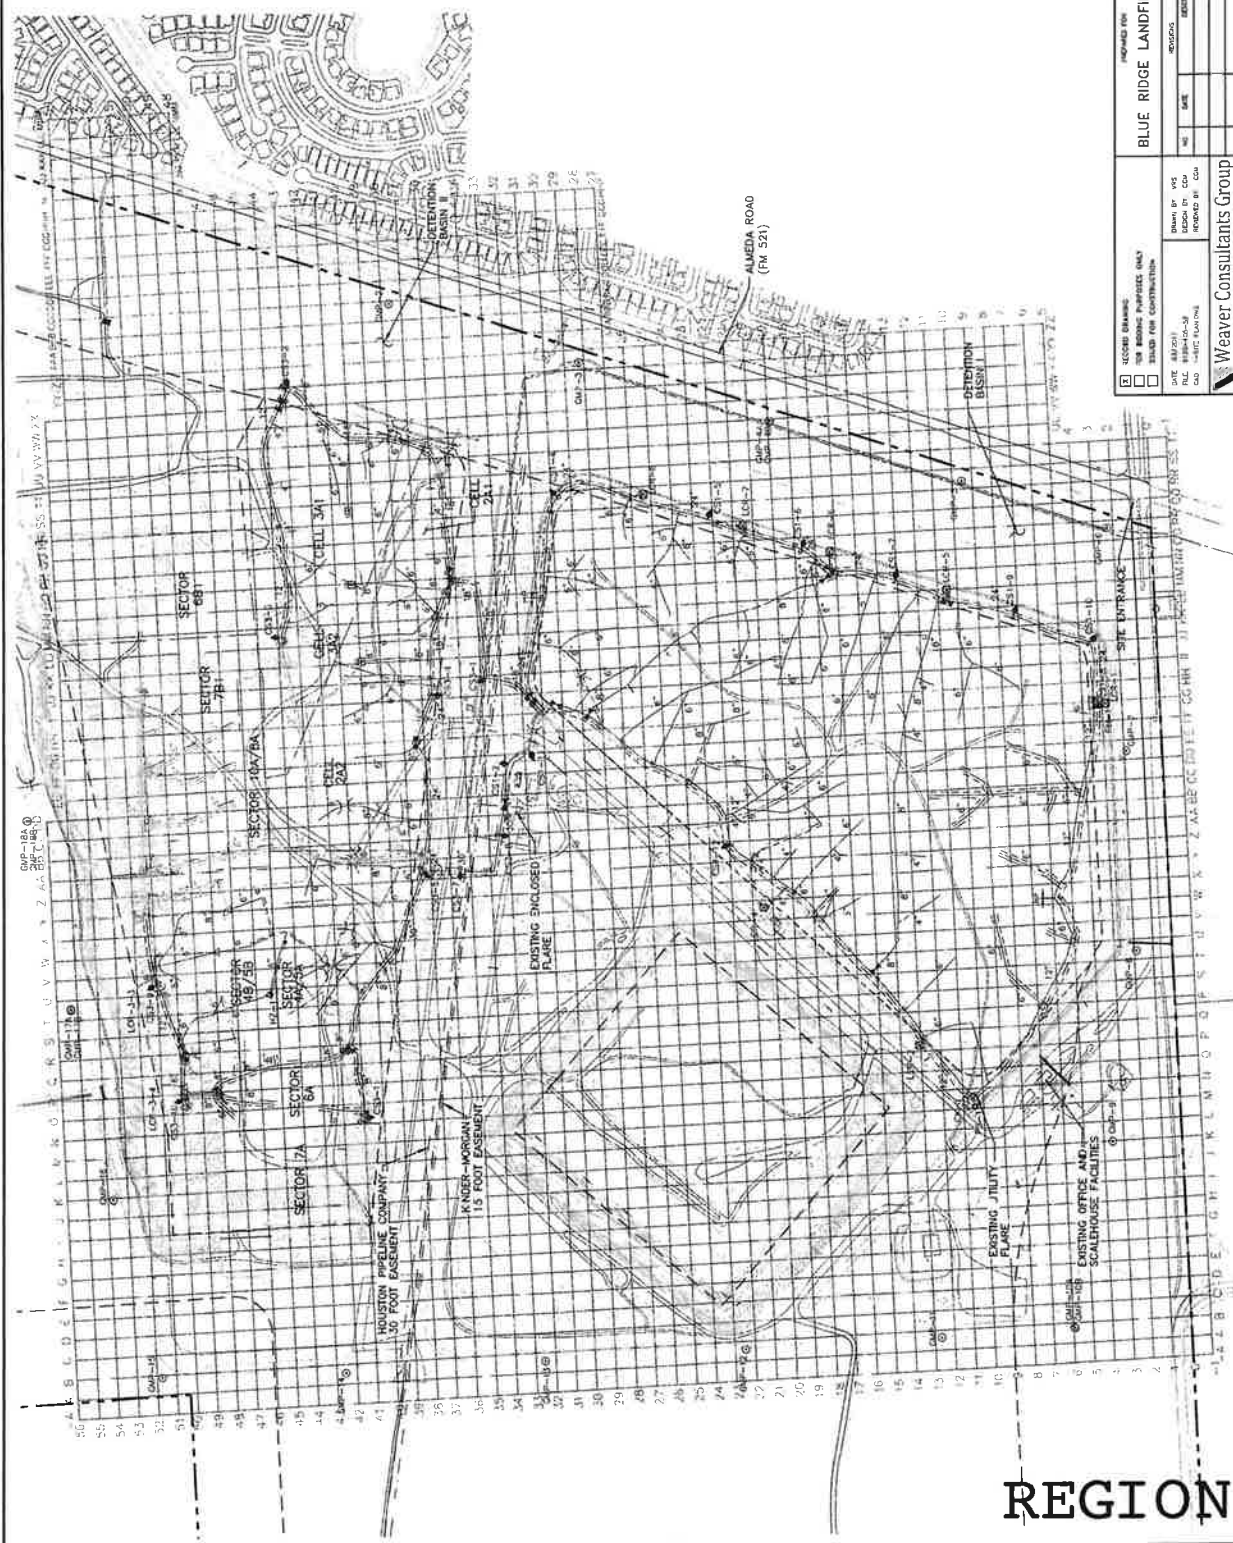
Per your letter dated July 11, 2018 approving additional time to repair erosion, Blue Ridge Landfill, TX, LP ("Blue Ridge") is providing the TCEQ Region 12 office with the sixth weekly progress in implementing the erosion corrective action. During week 6 (8/20/2018 – 8/26/2018), Blue Ridge completed all repairs on Phase 2.

On August 29, 2018, a letter (Attachment 4) was received from BRL, dated August 27, 2018. According to the letter, BRL completed repairs on Phase 2.
