TEXAS COMMISSION ON ENVIRONMENTAL QUALITY

Re: Investigation Request at:
Blue Ridge Landfill, 2200 FM 521 Rd, Fresno (Fort Bend County)
Regulated Entity No.: 102610102
TCEQ MSW Permit No.: 1505A
Investigation No.: 1518011

MSW PA_1505A_C_20180920_Investigation
Texas Commission on Environmental Quality
Investigation Report

Blue Ridge Landfill
2200 F.M. 521, Fresno (Fort Bend County), TX 77545
Municipal Solid Waste Permit No. 1505A
MSW Complaint Investigation
Conducted on September 20, 2018

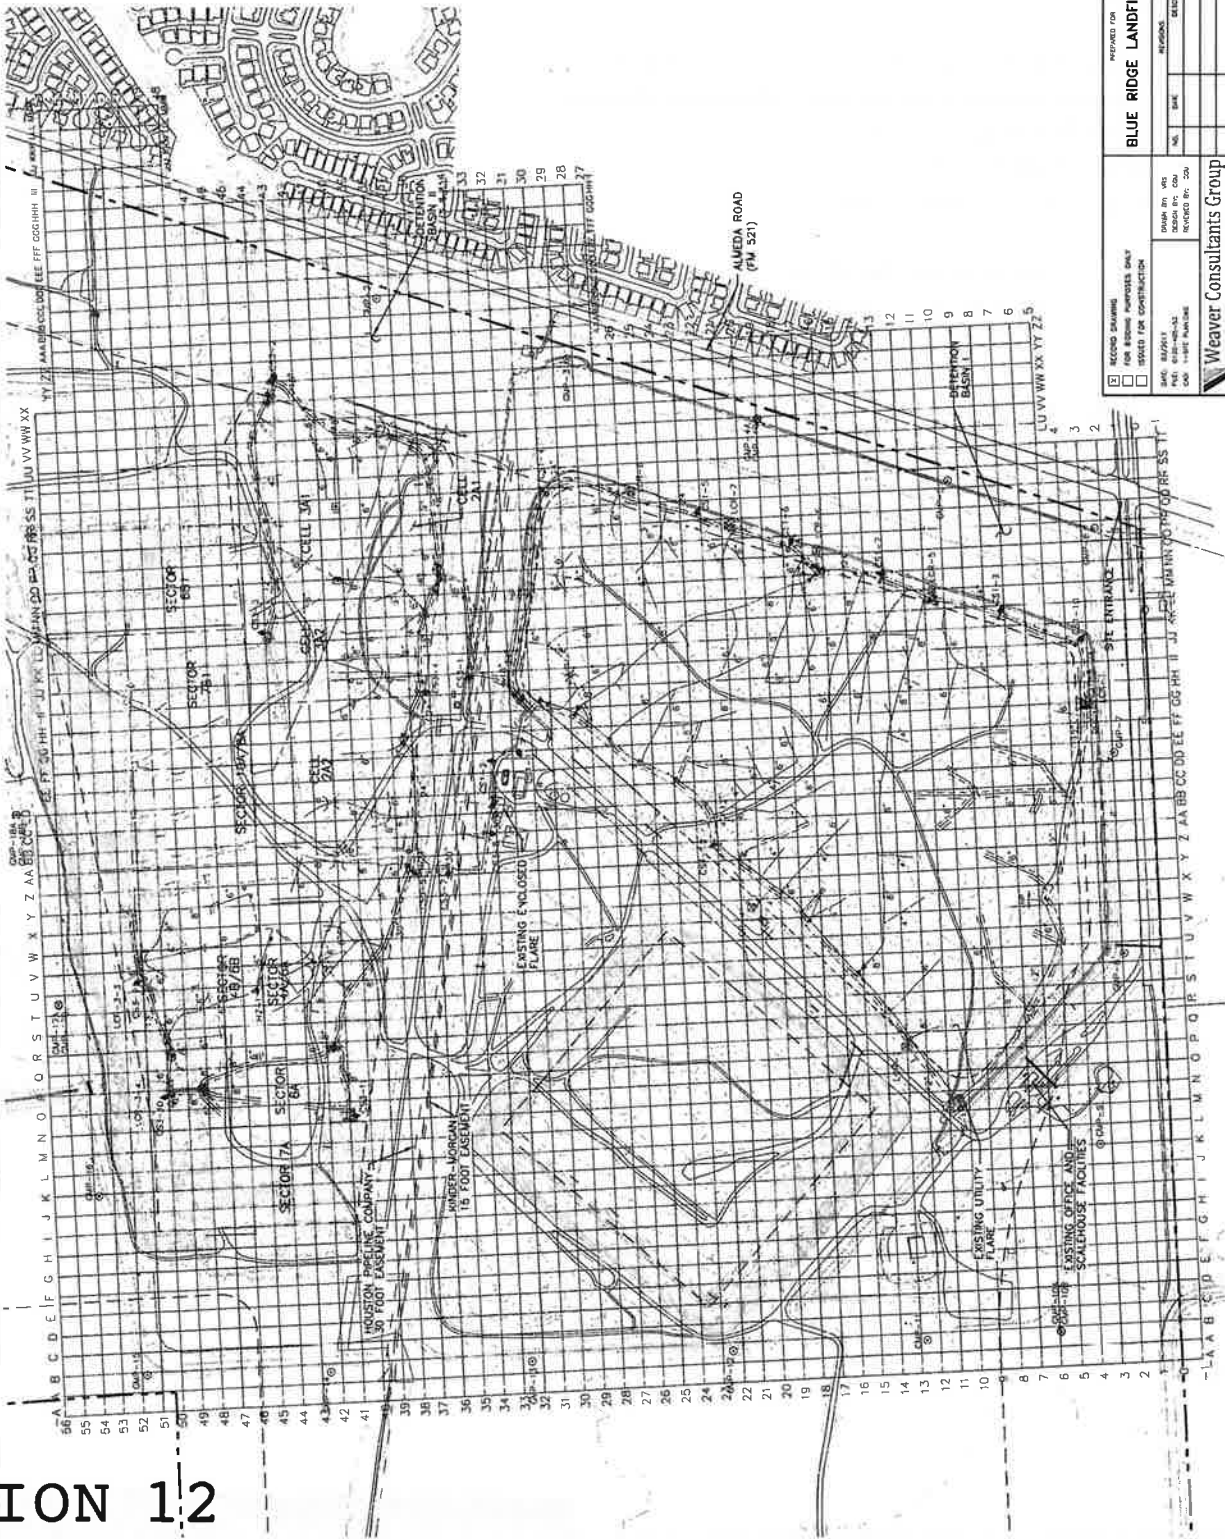
Per your letter dated July 11, 2018 approving additional time to repair erosion, Blue Ridge Landfill, TX, LP ("Blue Ridge") is providing the TCEQ Region 12 office with the eighth weekly progress in implementing the erosion corrective action. During week 8 (9/4/2018 - 9/10/2018), Blue Ridge did not complete repairs within the erosion extension areas because of rain out.

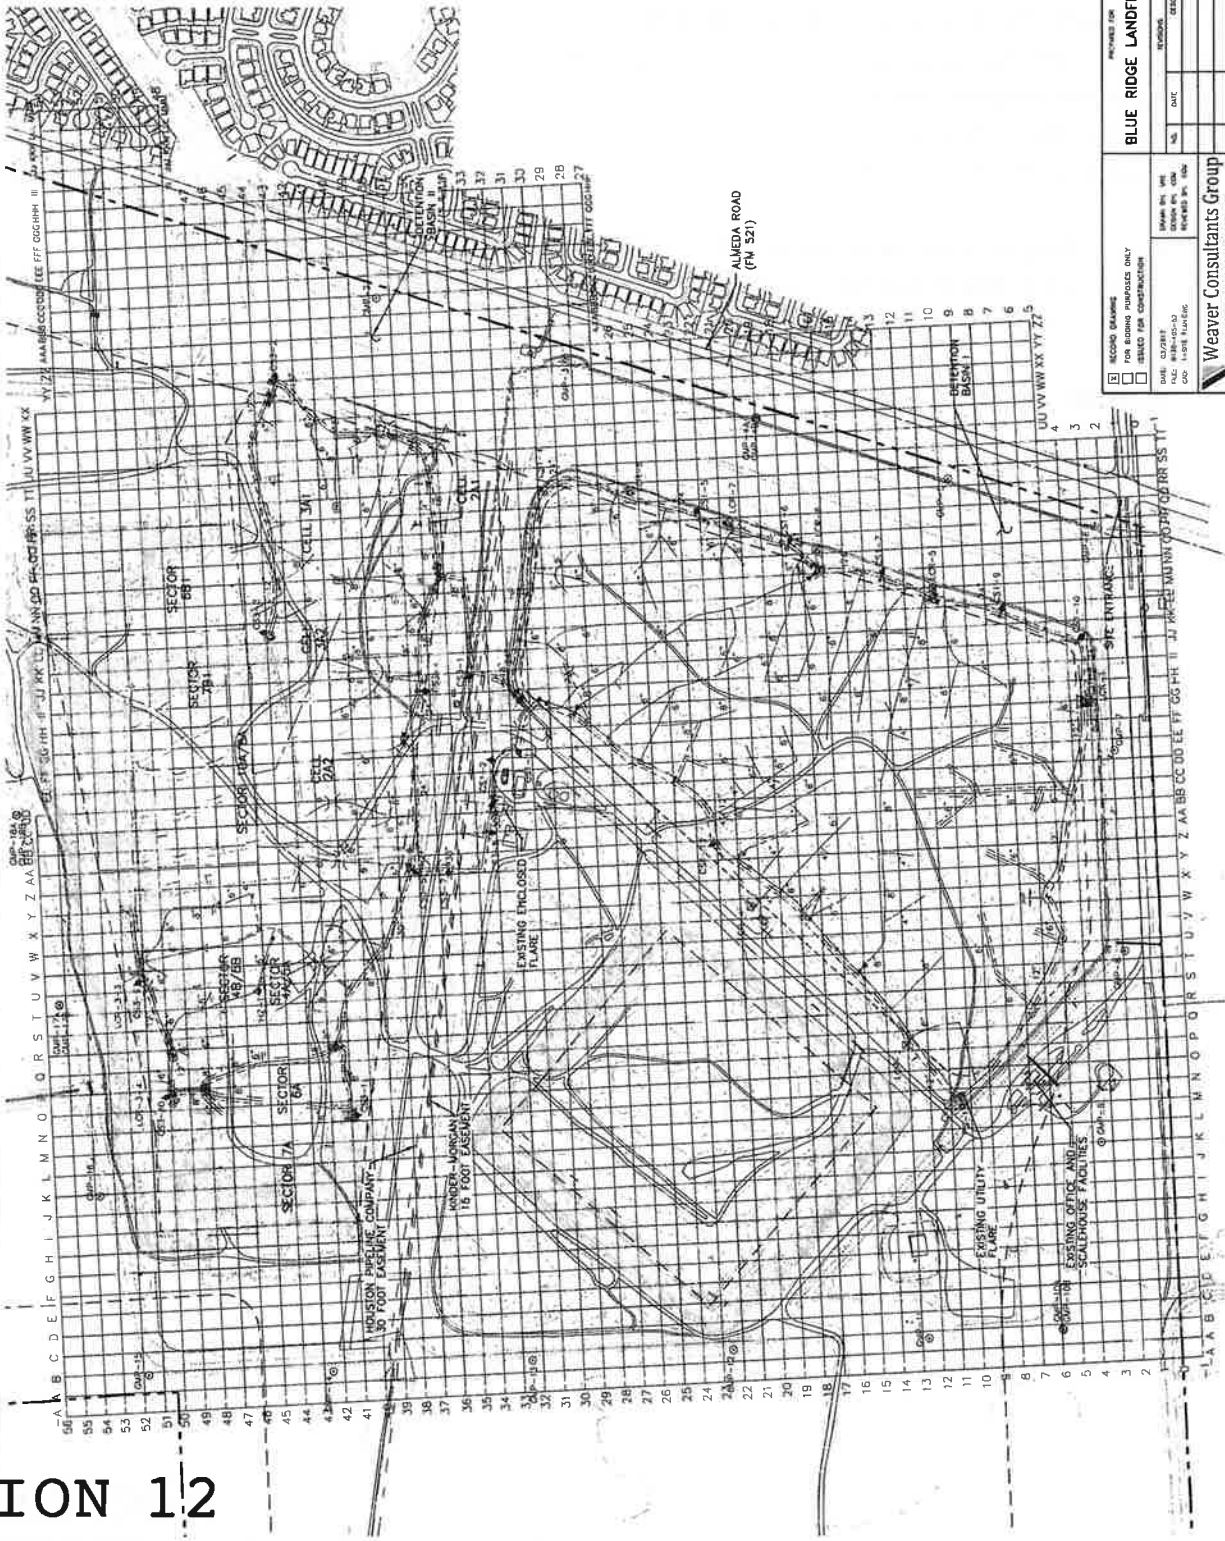
Per your letter dated July 11, 2018 approving additional time to repair erosion, Blue Ridge Landfill, TX, LP ("Blue Ridge") is providing the TCEQ Region 12 office with the tenth weekly progress in implementing the erosion corrective action. During week 10 (9/17/2018 - 9/25/2018), Blue Ridge did not complete repairs within the erosion extension areas because of rain out.
